**Arizona Public Service  
Westwing Substation Autotransformer  
Failure Analysis Report**

**Submitted By  
James B. Templeton  
Harold Moore & Associates, Inc.  
December 11, 2004**

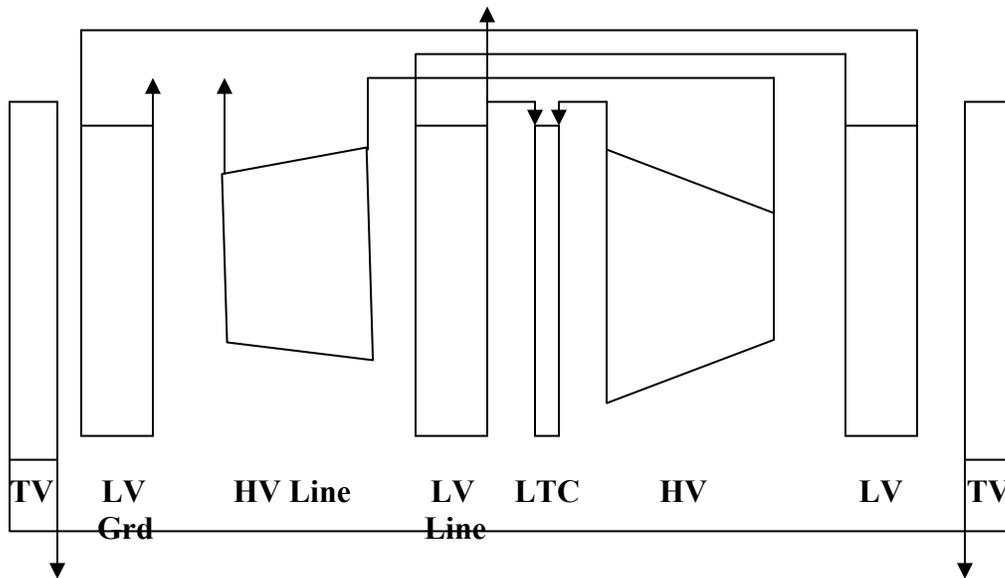
**Figure 1**

In this sketch the HV line lead connects to the left side of the block labeled as HV line. The various blocks of the HV and LV are connected in series to accomplish the autotransformer connection and the winding blocks are interleaved with 4 gaps between the winding blocks. The TV winding is arranged on the outermost ends of the phase. The LV line is connected to the terminal in the middle LV group, which is labeled as LV Line. The neutral terminal is connected to the terminal of the LV Grd. group. Finally, the TV bushings are connected to the terminals associated with each of the two TV groups. This winding arrangement was typical for an autotransformer at the time this transformer was manufactured. The clearances between coils were also in line with the clearances for the voltage class of these windings.

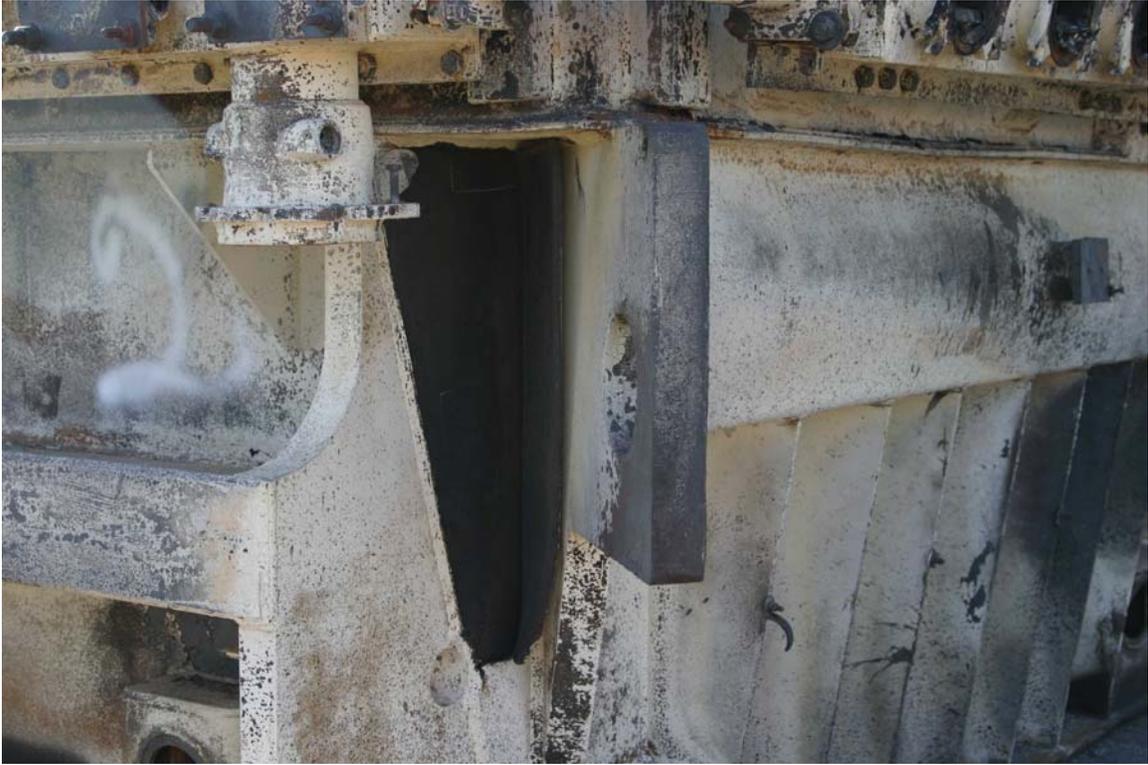
Photo 1

This photo shows one of the corners of the low tank section of the phase 2 transformer of the T1 bank. The dark area was an area of failure of the base metal of the intersecting parts of the tank structure. This is indicative of high stresses in this region of the tank.

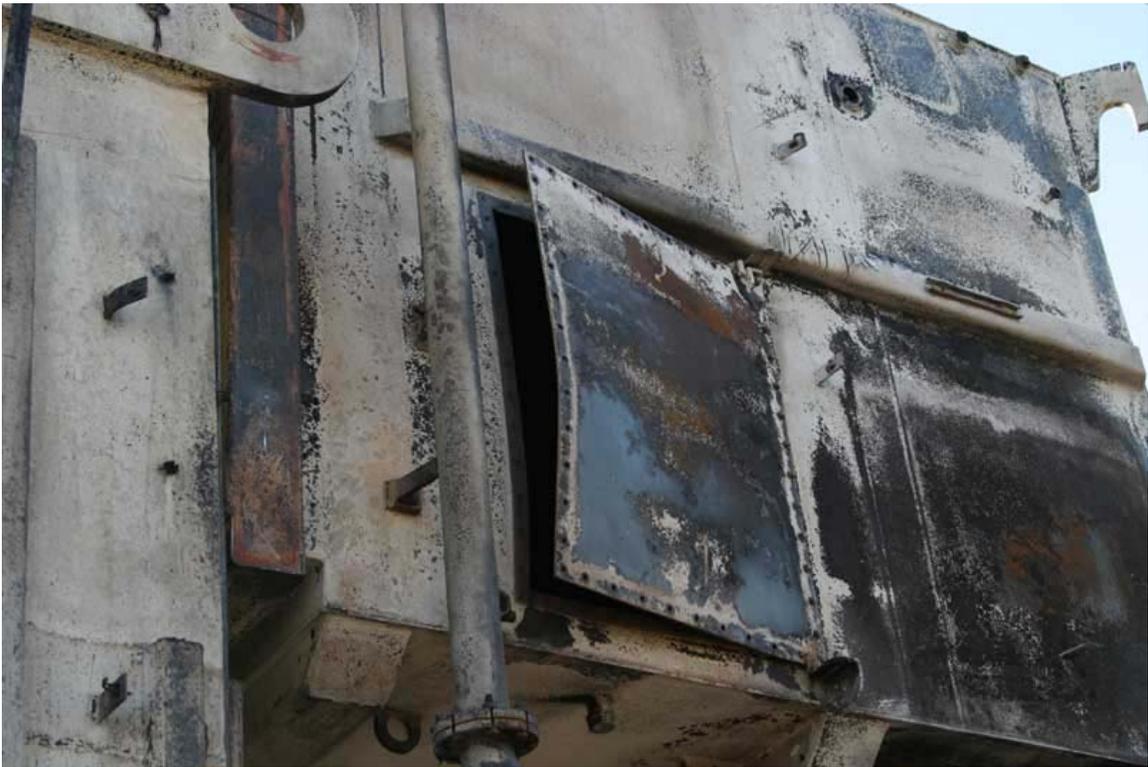
**Photo 2**

In this view the LTC compartment of the phase unit of the T1 bank is shown as viewed from segment 2 of the tank. This breach to the oil system occurred during the failure event. This was the only unit that had this type of damage. It is also indicative of fault pressures having occurred in the LTC compartment.

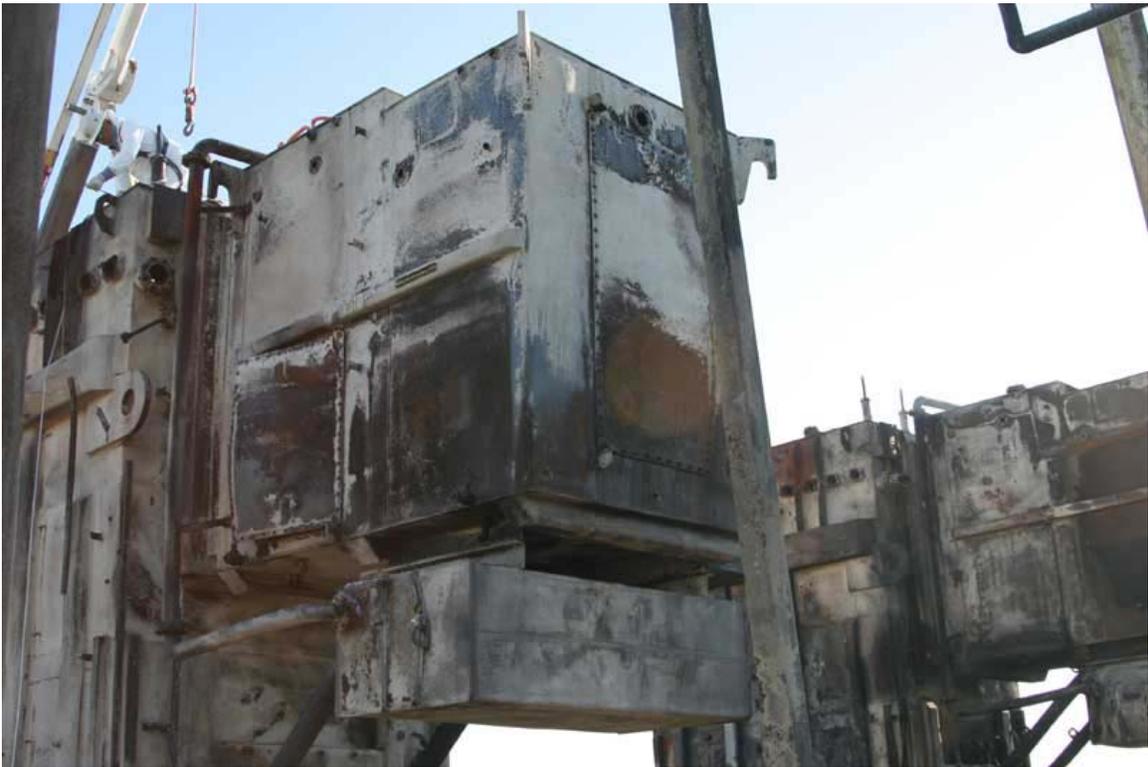
**Photo 3**

In this view of the phase 2 unit one can see the inspection door blown open on the left side of the LTC compartment as well as a deformed inspection door on the front off the LTC compartment. In this view it is the inspection door that is in the center of the photo. Although the bolts have not failed and the oil seal was not broken, it is obvious that high pressures were developed in the outer compartment of the LTC.

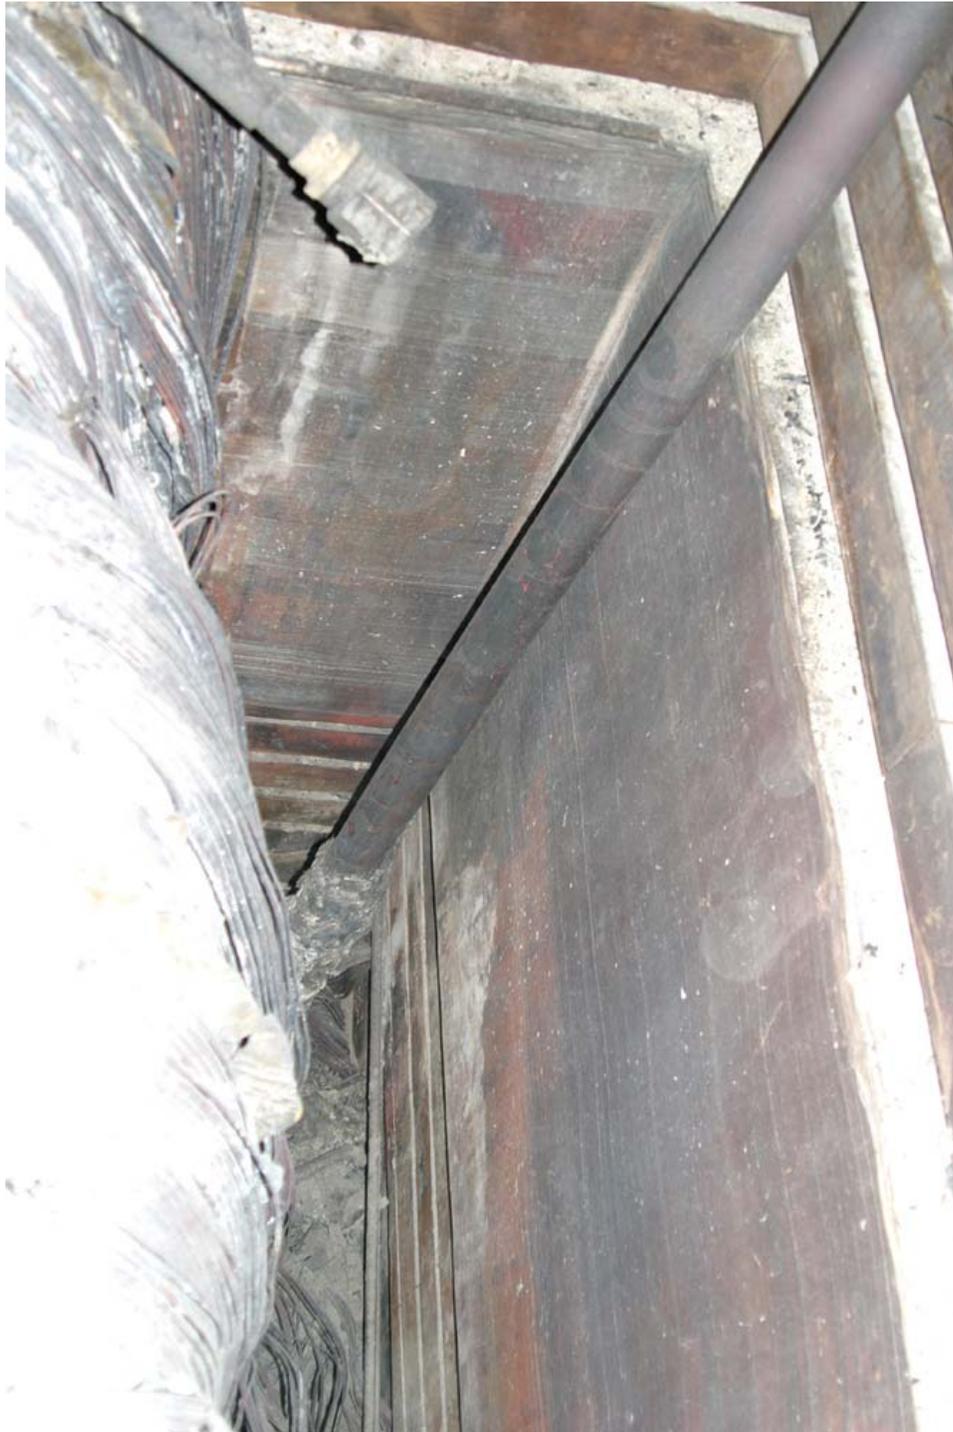
**Photo 4**

This photo was taken inside the phase 2 unit. The structure to the right is a portion of the core steel and the windings are to the left. The open area was originally filled with insulation that was consumed during the fire. The long tube is the conductor for the LV bushing.

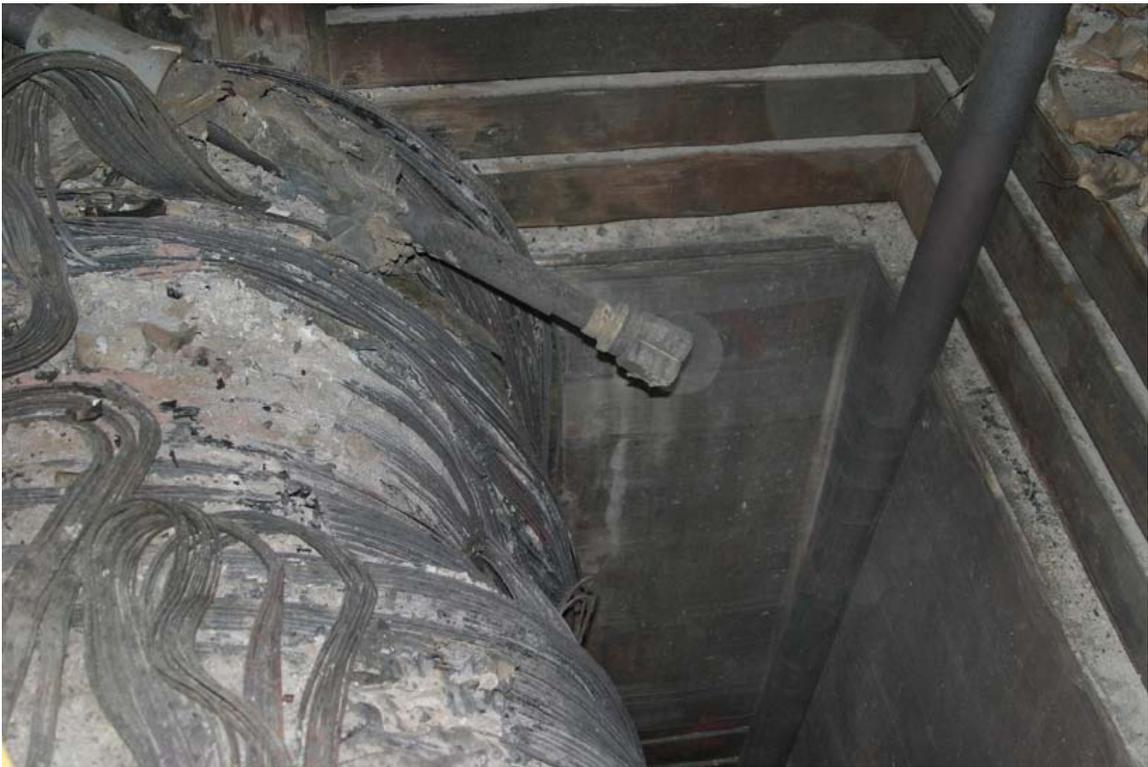
**Photo 5**

This is another view of the top of the phase. The conductors are shown collapsed, which took place as the insulation burned away. When the insulation was consumed there was no structure to support the radial build of the pancake coils. As such, the coils could only be distinguished if one knew the conductor sizes in each winding. This information was not available at the time of this inspection/

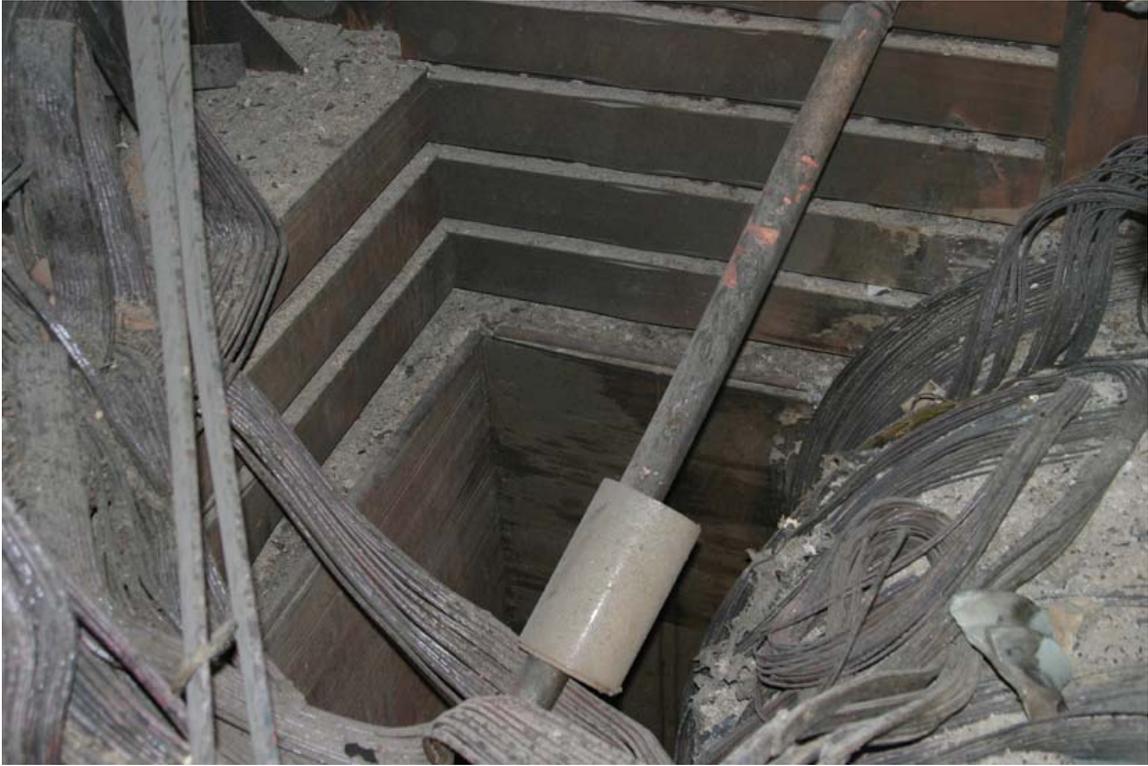
**Photo 6**

This is a view of the phase on the LV side of the transformer. A portion of the LTC tap leads is shown to the left.

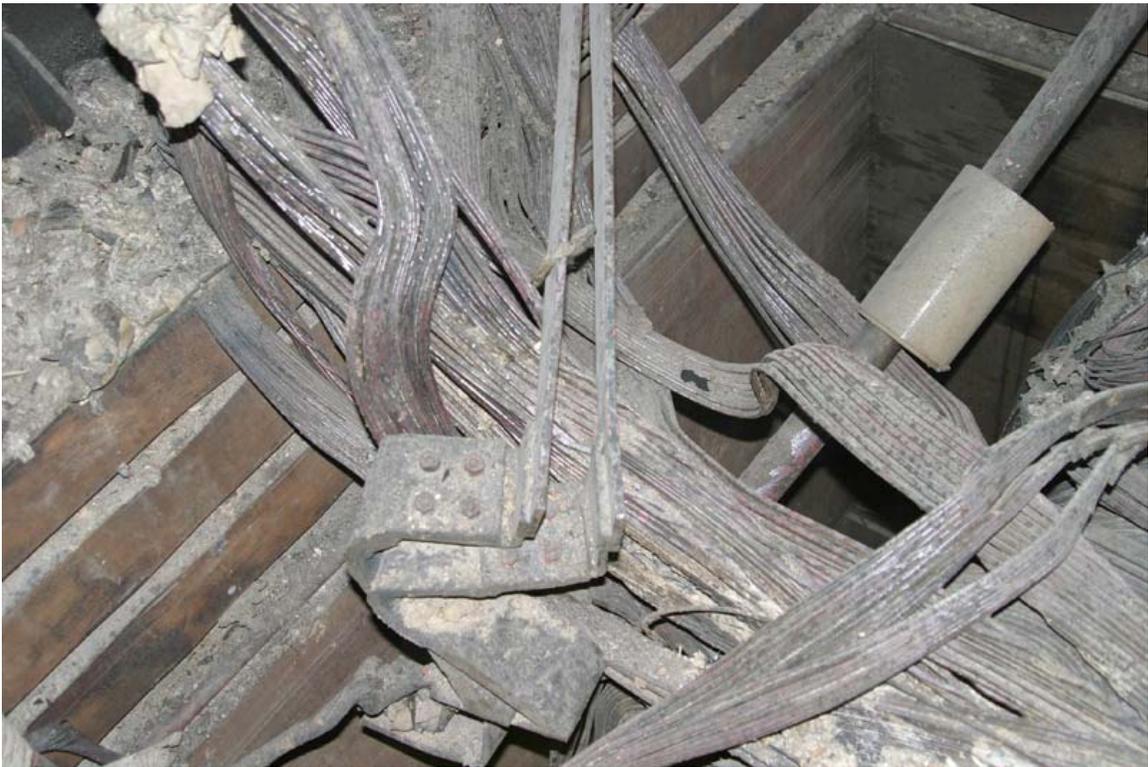
**Photo 7**

This is a view of more of the LTC leads from the phase to the LTC compartment. There were no indications of any conductor damage of the tap leads.

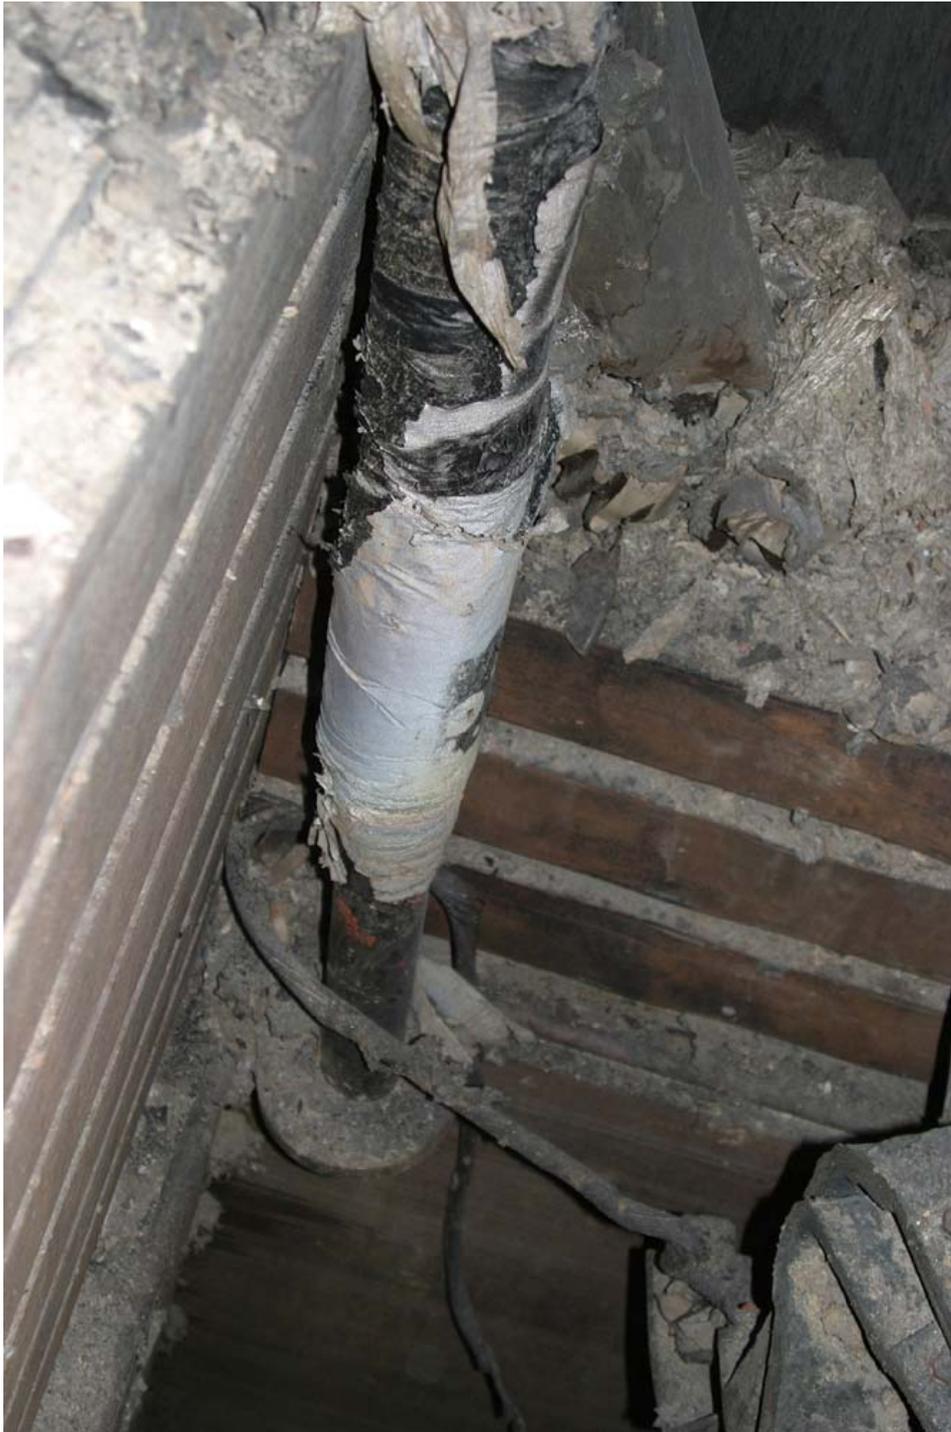
**Photo 8**

This is a view of the internal end of the HV bushing. As can be seen, the fire destroyed most of the internal portion of the condenser.

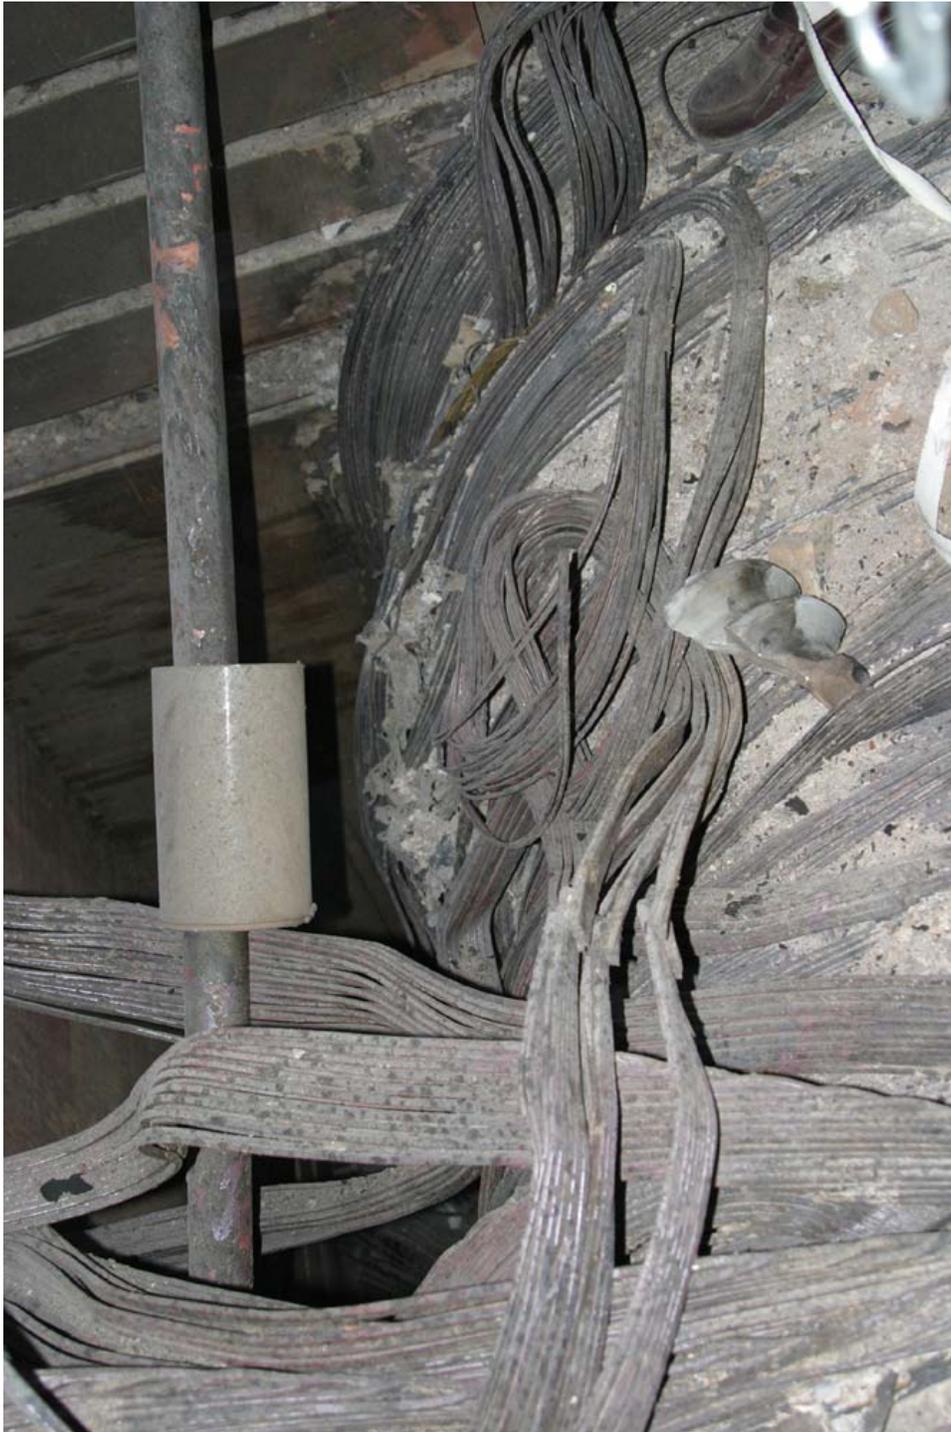
**Photo 9**

This view is of the LV leg of the phase from the top. From this vantage point, it did not appear as though any major deformation occurred in the conductors in this region.

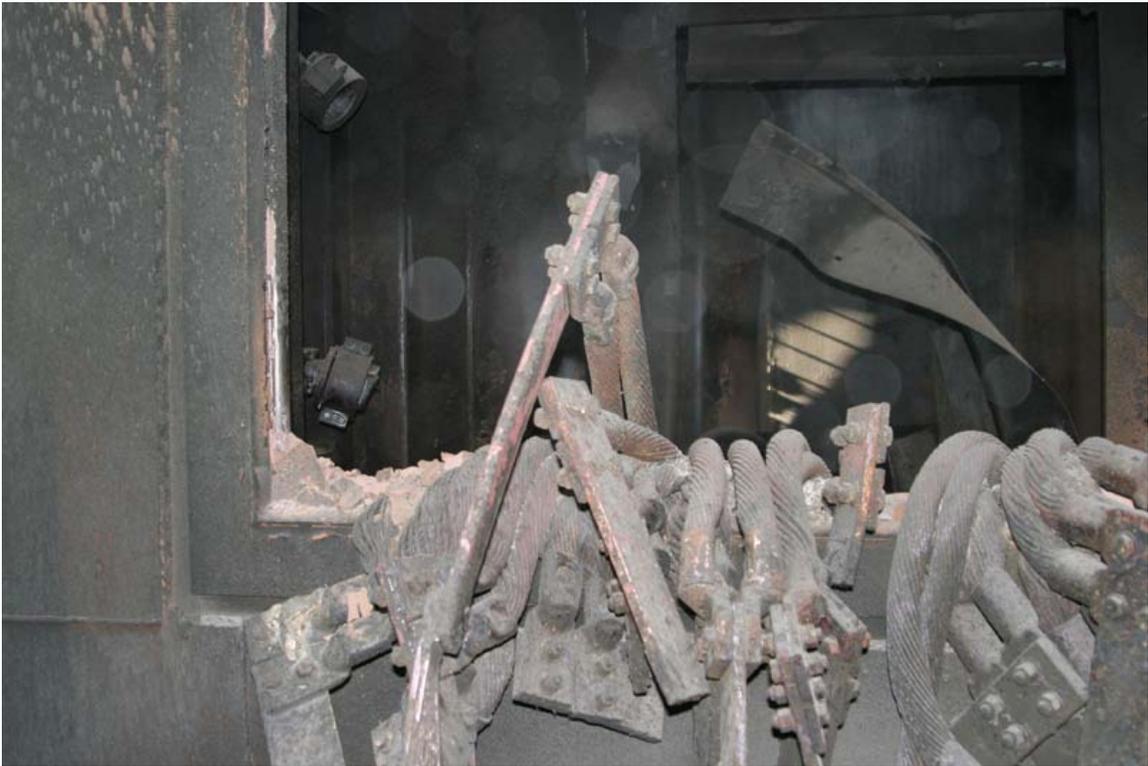
**Photo 10**

This view shows the routing of the LTC tap leads toward the LTC compartment. The opening in the tank wall is not normal. There is an epoxy barrier board with connectors molded into the board so as to provide a separation between the transformer oil volume from the oil volume in the LTC compartment. The barrier board was destroyed in the failure. The frame for the board was deflected outward from the transformer side, thus the board may have blown out during the failure rather than having been burned in the fire.

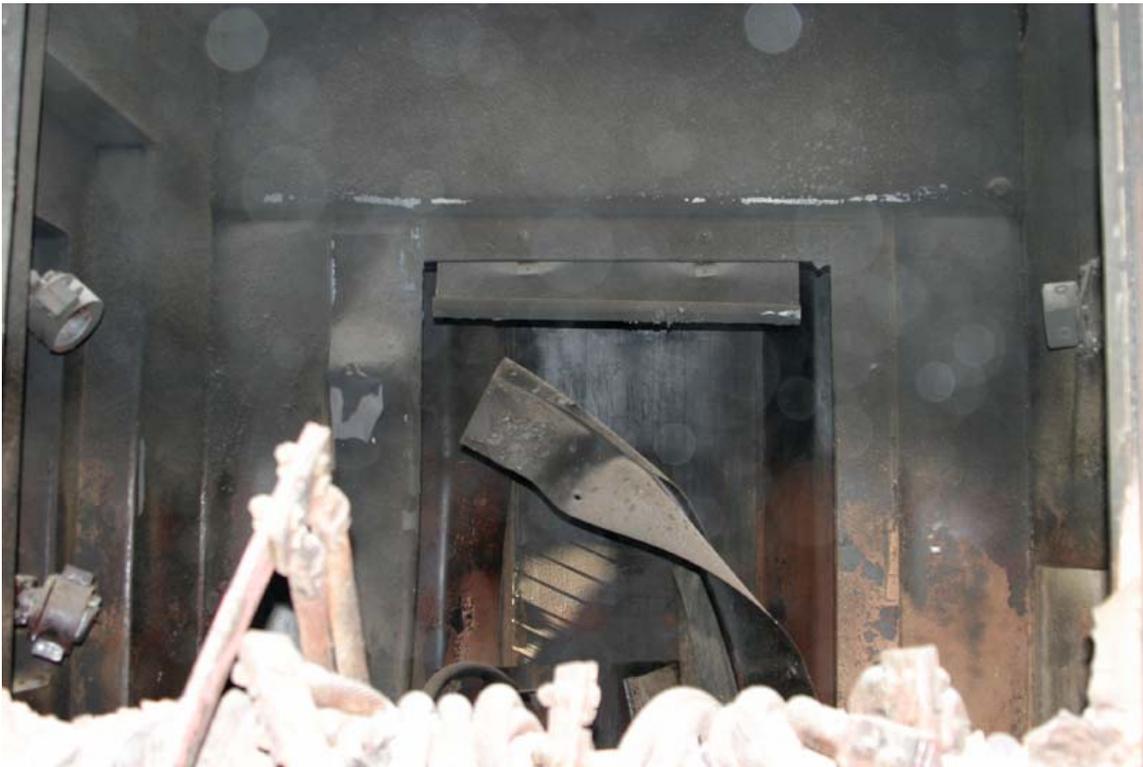
**Photo 11**

In the background of this photo is another opening depicted by a rectangular frame. There is normally another barrier board mounted in this frame to form a barrier between the transfer switch compartment and the selector switch compartment. The barrier board was destroyed in this unit as well.

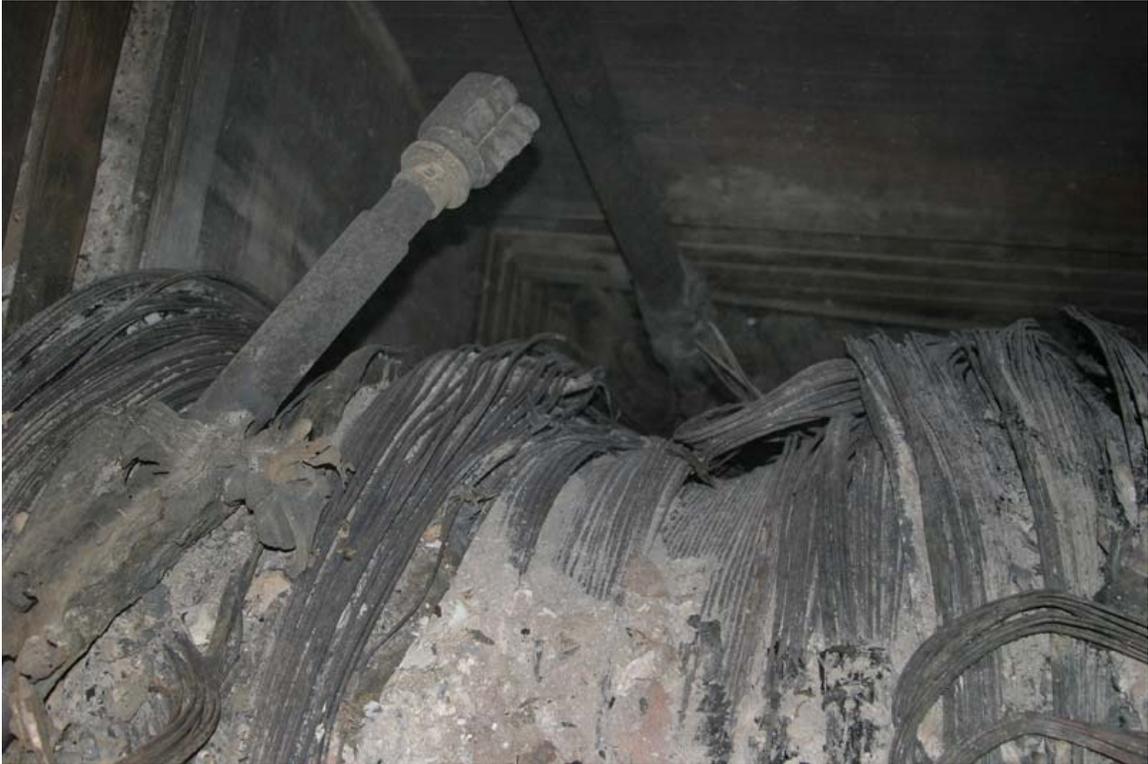
**Photo 12**

This is a view of the phase along the leg on the HV side of the transformer. Near the middle of the photo there is deformation of the conductor. It appeared the deformation was located along the leg of the coil further down the height of the coil that was not visible from the top of the phase.

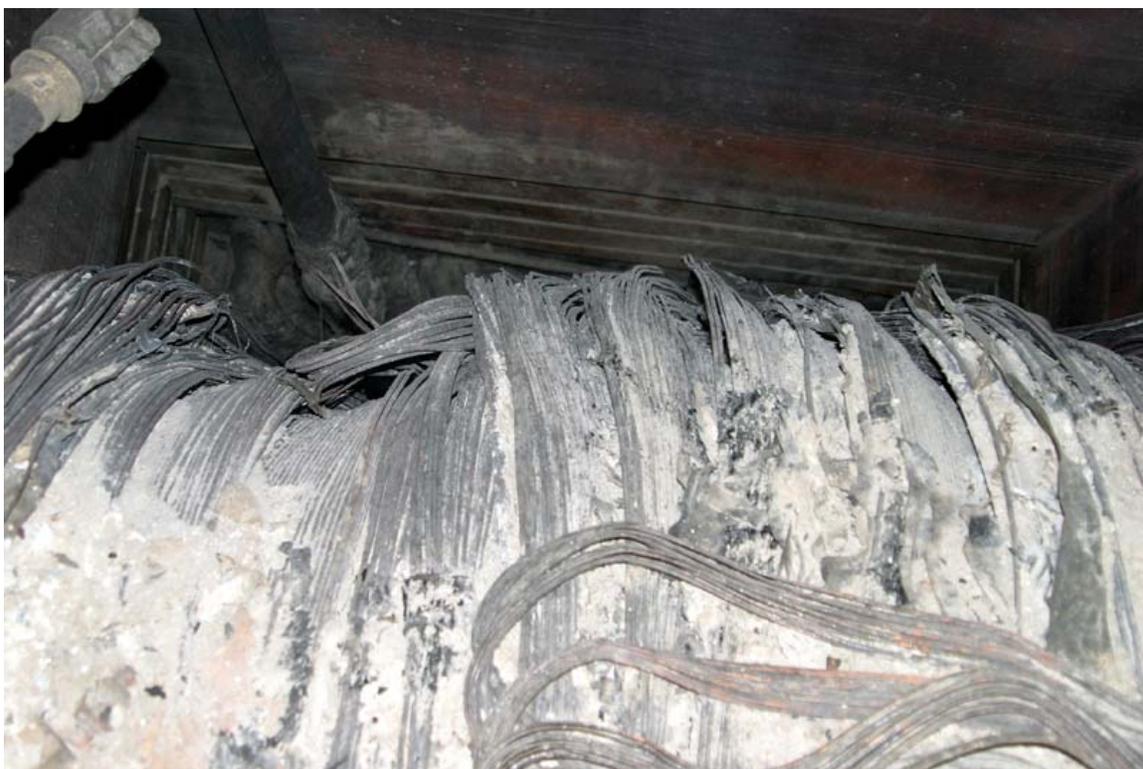
**Photo 13**

This is another view of the HV side of the phase. The deformation is more prominent in this view.

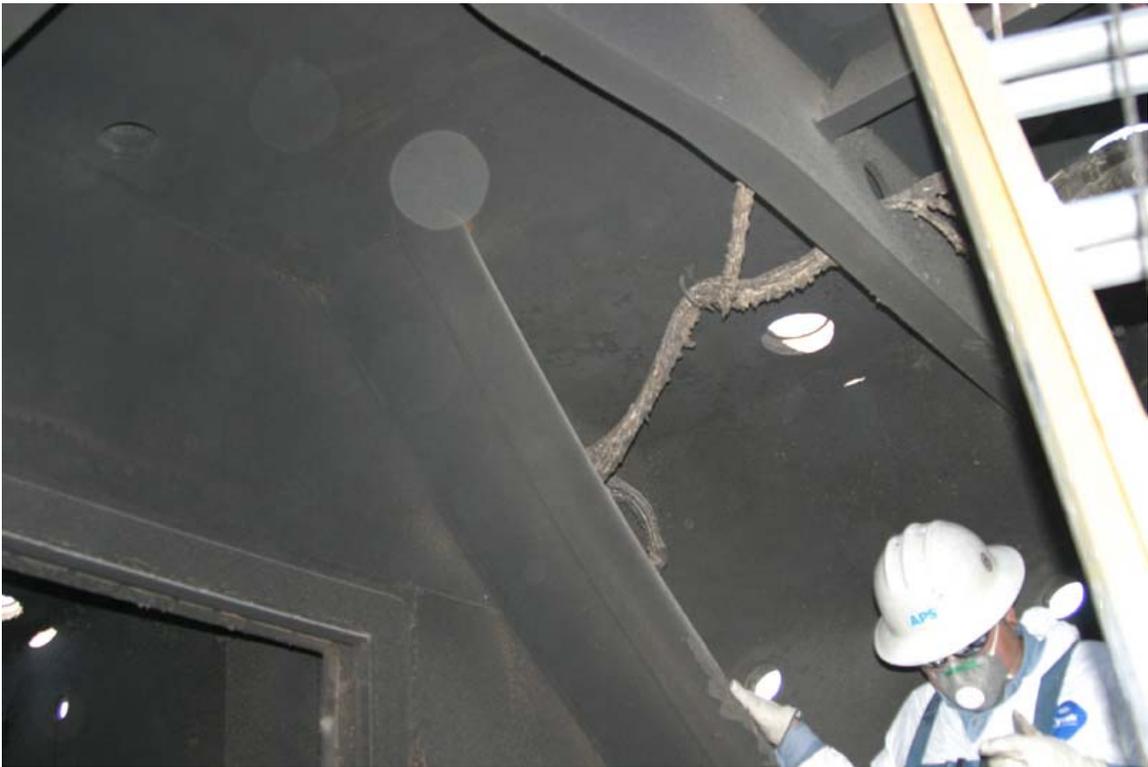
**Photo 14**

This a view of the inside surface of the top of the transformer tank. This view shows deformed braces on the tank. These may have been deformed during the failure due to internal pressure or by the heat of the fire.

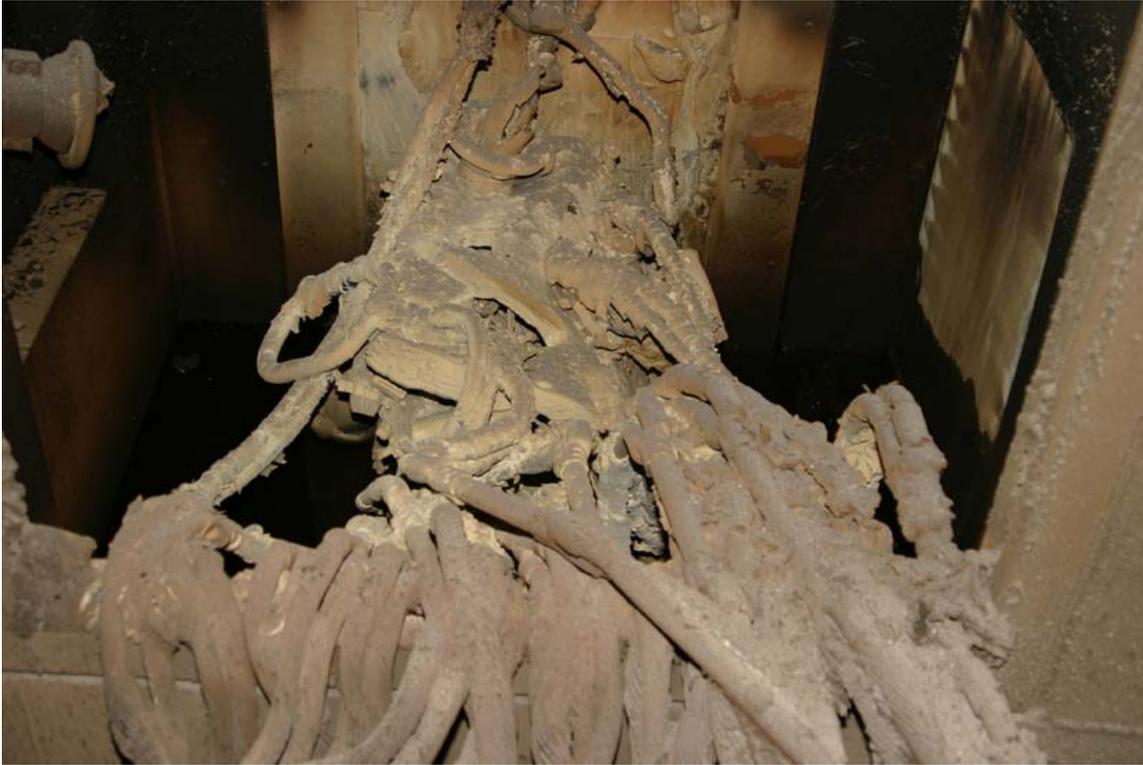
**Photo 15**

This is a view of the leads routed into the LTC compartment. As with the phase 2 unit, the barrier board between the transformer and the LTC compartment is destroyed. A major difference is that the board between the transfer switch compartment and the selector switch compartment is still in place. Although not shown, the inspection doors in the LTC compartment were not deformed and the oil seals were not broken.

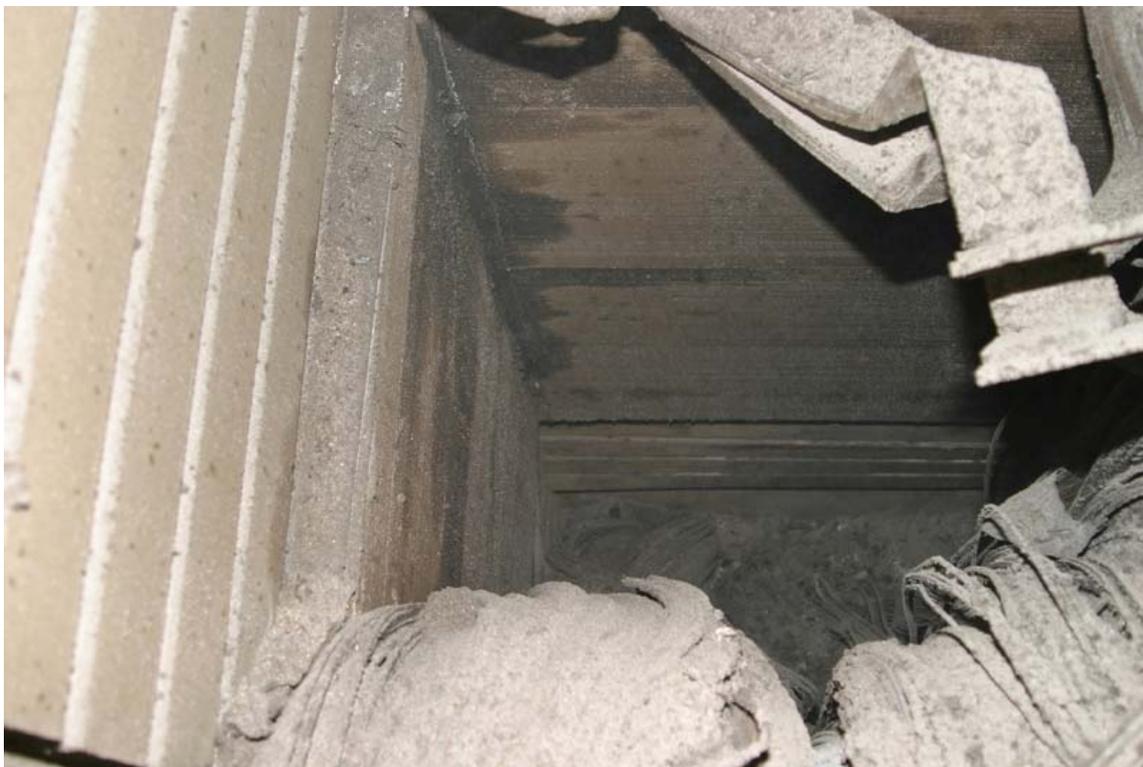
**Photo 16**

This is a view along the LV side of the phase. There were no obvious areas of deformed conductor along this side of the windings.

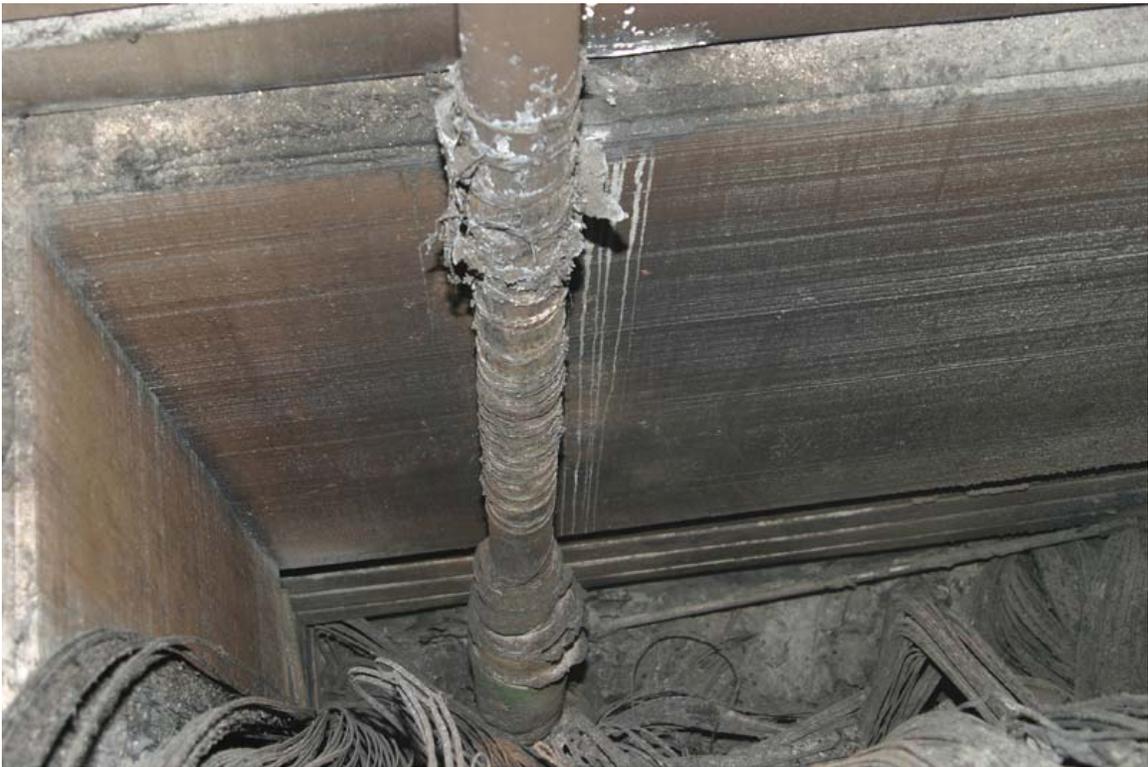
**Photo 17**

As with the phase 2 transformer, the bushing in this transformer was also destroyed. This is the internal end of the LV bushing.

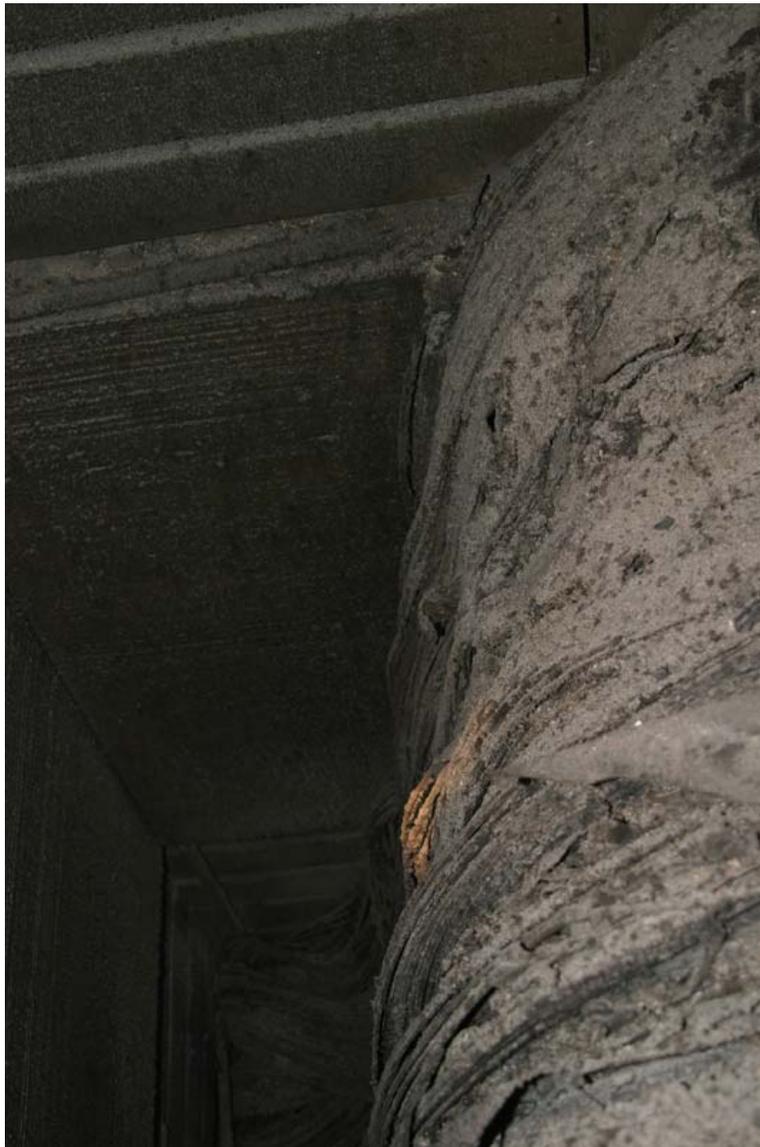
**Photo 18**

This is a view of the phase along the HV side of the windings. There was a distinct difference between the two transformers with this one not showing the indications of deformed conductors.

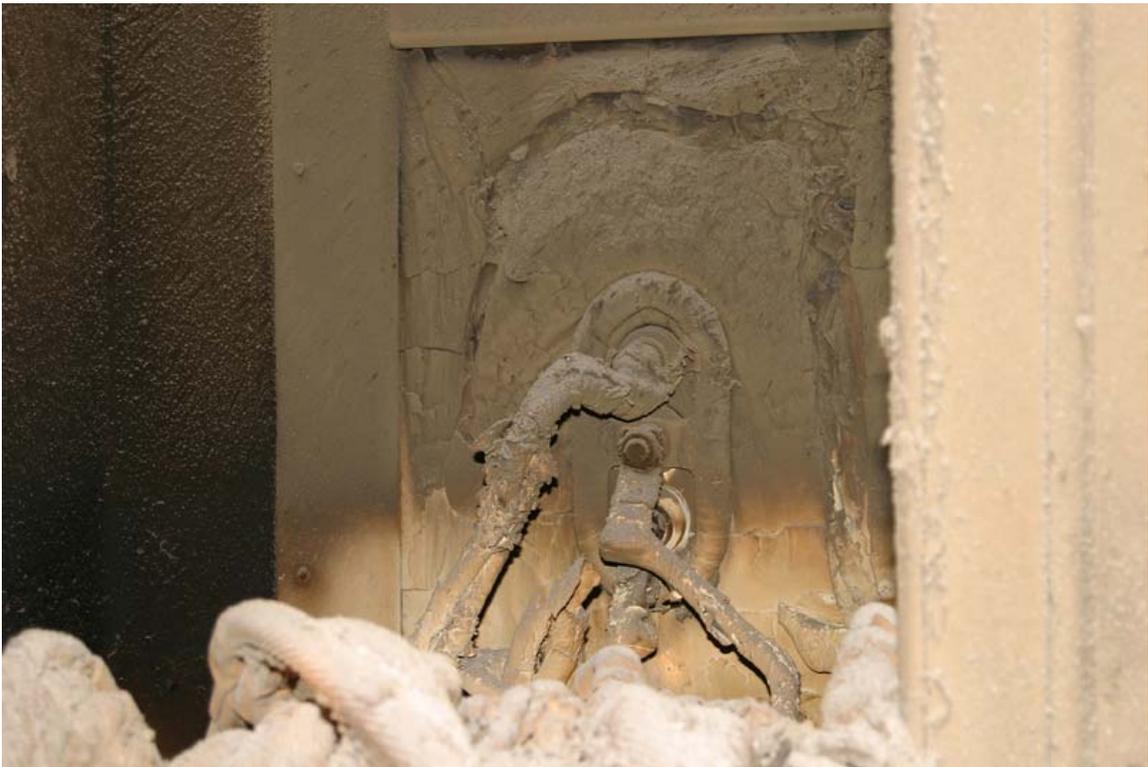
**Photo 19**

This is a view of the barrier board between the transfer switch and selector switch compartment. Although the surface was burned, the board was essentially intact.

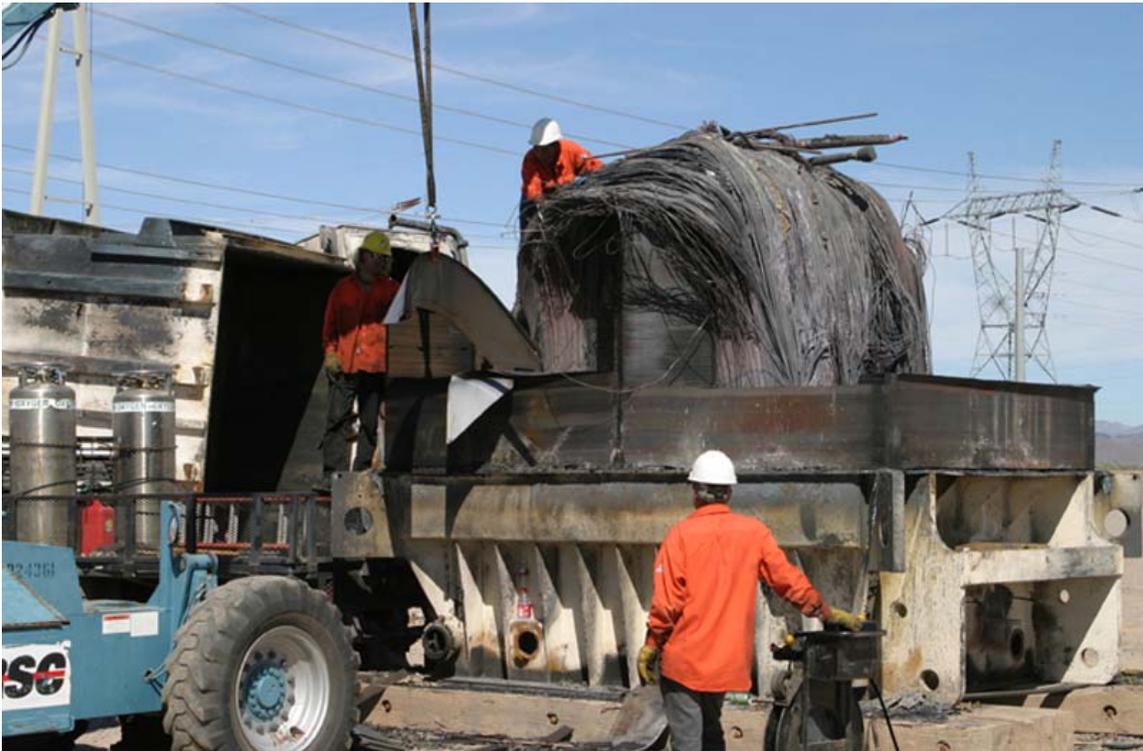
Photo 20

This is a view of the active part being disassembled with the top tank removed. A portion of the core has already been removed at this point. Note the position of the conductor as it is wrapped around the core steel through the center of the coils. The design information was available at this point and conductors were measured to determine the winding to which they were associated.

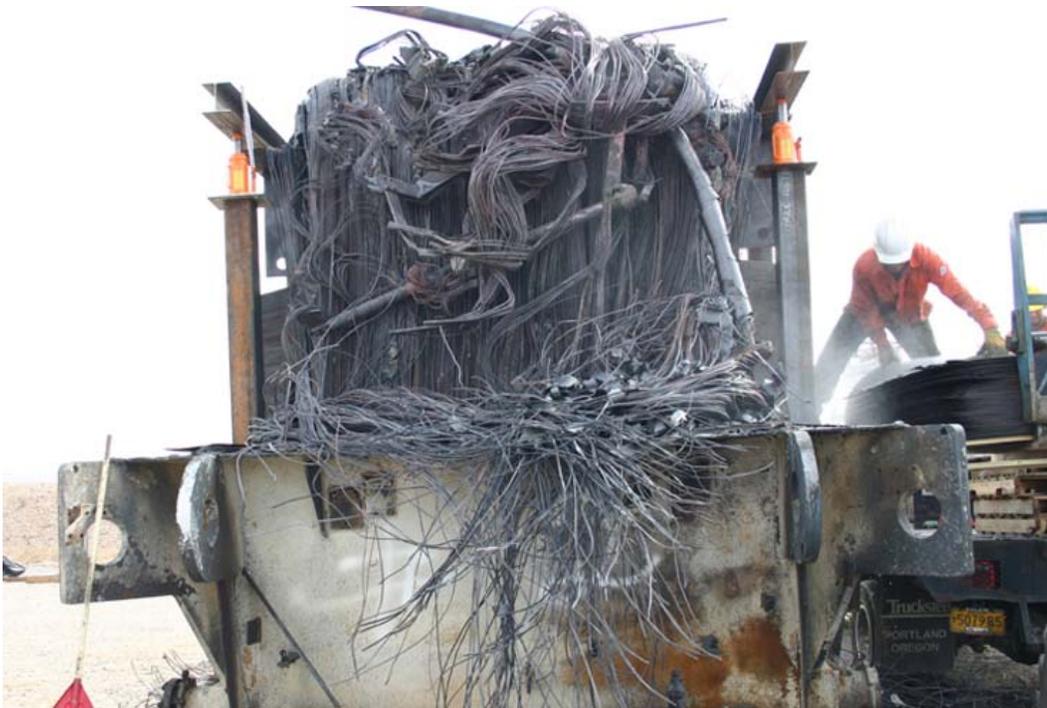
**Photo 21**

This is a view from the LV side of the phase. The majority of the jumbled conductor in this view is from the LTC leads that have no support. All of the core has been removed at this point.
