**Arizona Public Service  
Westwing Substation Autotransformer  
Failure Analysis Report**

**Submitted By  
James B. Templeton  
Harold Moore & Associates, Inc.  
December 11, 2004**

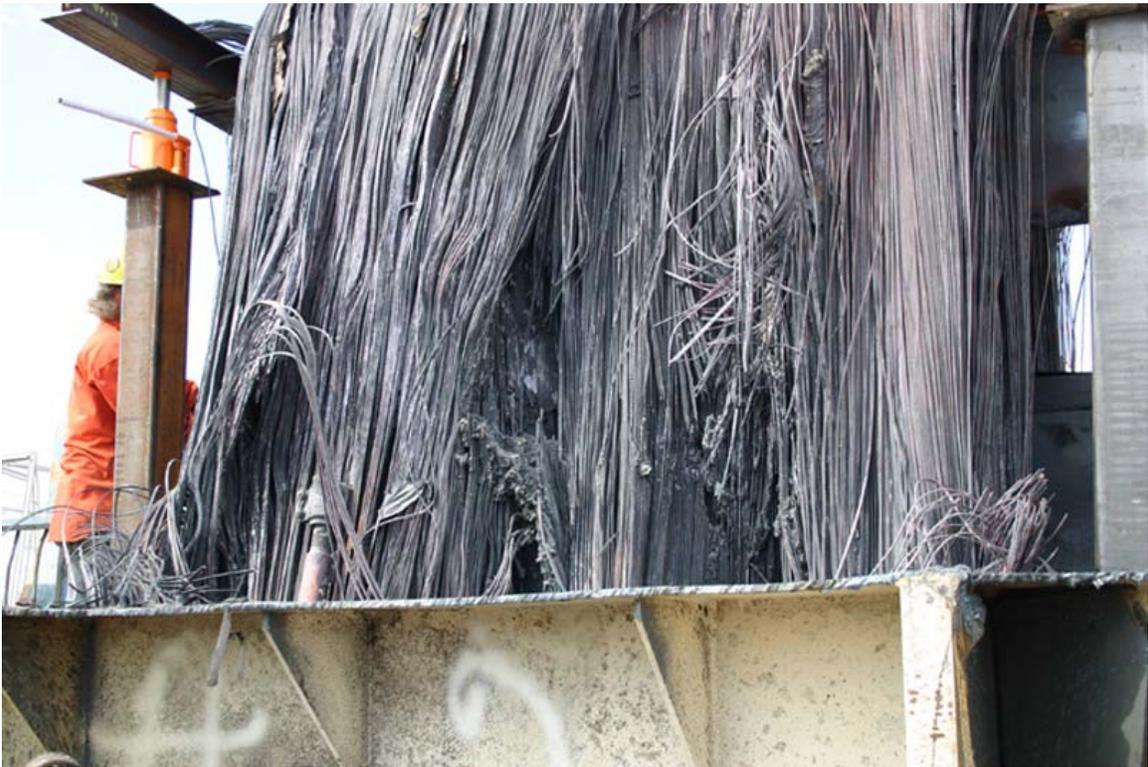
**Photo 22**

The observations made of T732 are documented in Photos 20 – 27 in Appendix A.2. The prominent observation of the phase assembly was two areas of broken conductor strands on the HV side of the phase. The region of the broken strands was in the outside leg of the coil, which is a region surrounded by core steel. One of the regions of broken conductors was in the HV line group. This was the one with the greatest amount of fractured conductors. The overall area was approximately 8 inches wide and 18 inches long. This is a large number of open conductors. The ends of the conductors were not characterized as shear surfaces but rather as conductors that had burned through by electrical arcing. There was also conductor deformation associated with the region of open conductors.

This is a view of the windings from the HV side. There are two areas of major conductor damage on this side of the phase. There is one area toward the right end of the phase where the conductors are broken and melted. The other area is toward the center of the phase.

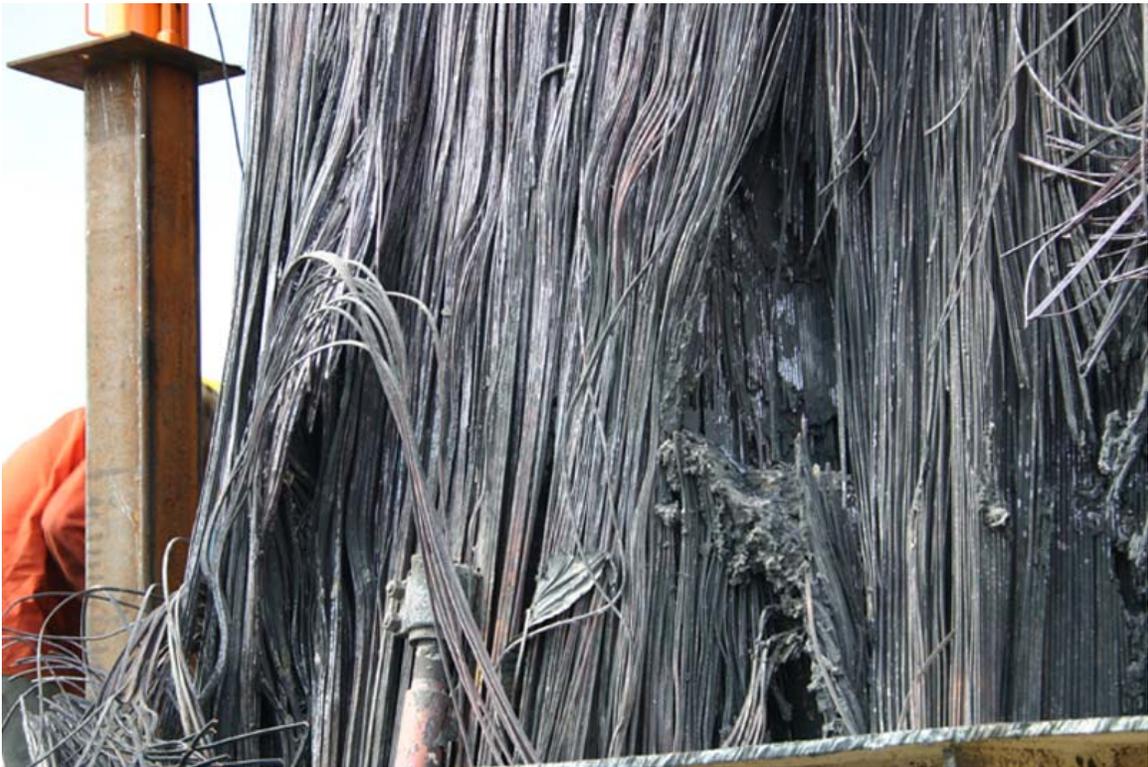
**Photo 23**

This is a view of the area toward the center of the phase. The conductors are broken and melted.

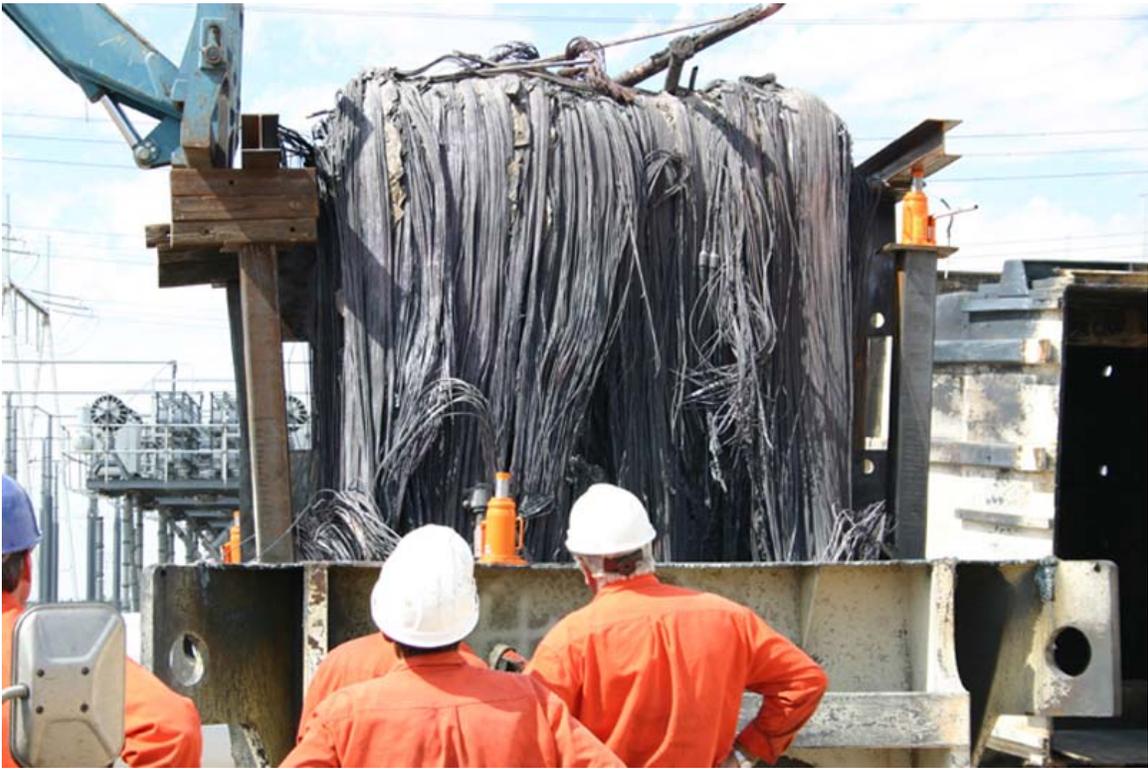
**Photo 24**

This is an overall view of the HV side of the phase. The areas of fault in the conductors are in the center and the right end of the phase.

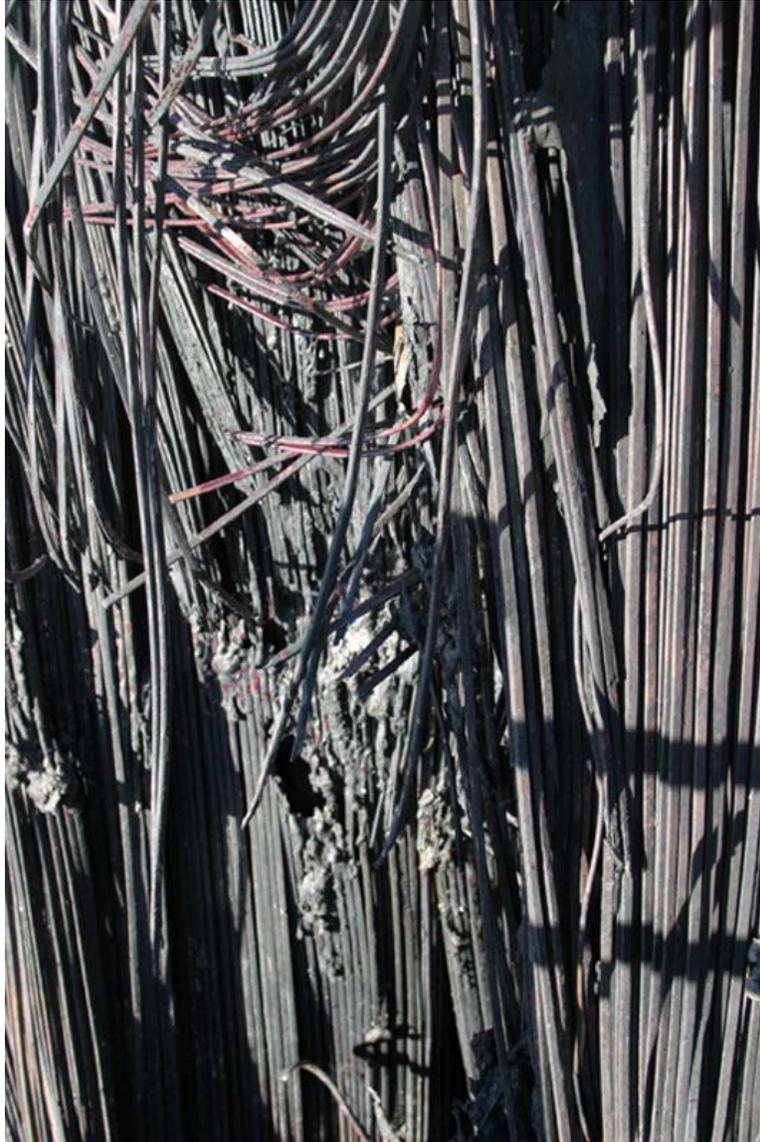
Photo 25

This is a close-up view of some of the damaged conductors on the HV side. The conductors are twisted, broken, and melted.

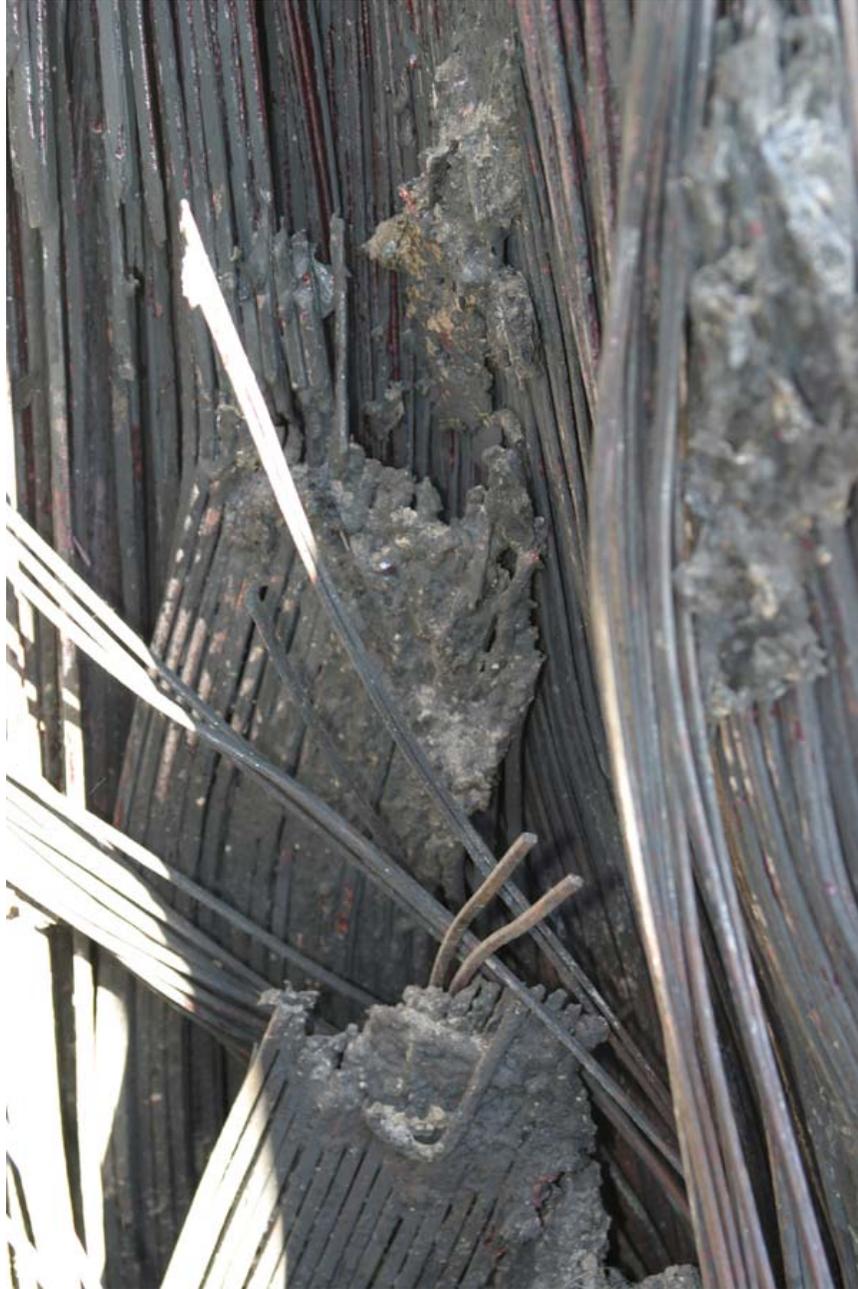
**Photo 26**

This close-up view shows a large number of melted conductors on the HV side of the phase.

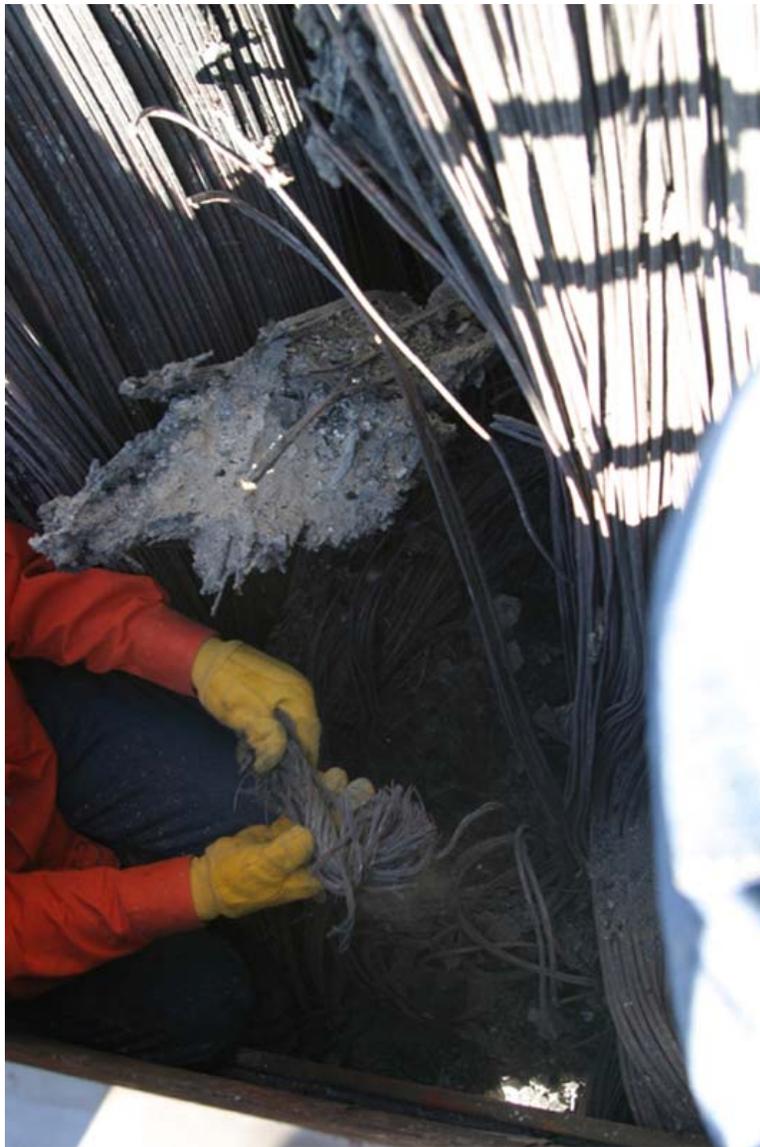
**Photo 27**

In this view one can see a large piece of solidified molten copper. A relatively large amount of energy was dissipated in this region to melt such a large portion of the winding. This area involved multiple coils, but it was not possible to determine the exact coils due to the collapse of the coils after the fire consumed the insulation.

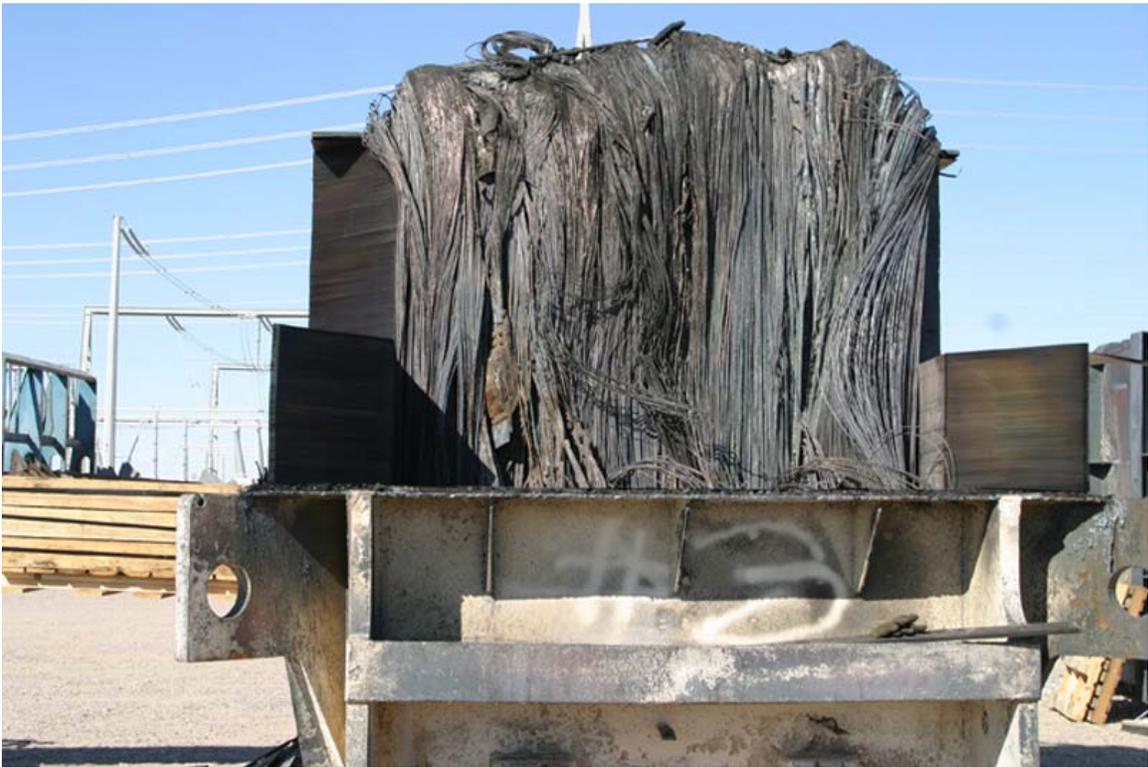
**Photo 29**

The conductor was in a similar general condition as with T732 in that the consumption of the insulation allowed the conductor to collapse. There were no signs of conductor deformation or broken conductors in this transformer. The phase was removed from the bottom tank section, thus revealing all surfaces of the coil assembly. There were no indications anywhere of broken strands or deformation as was the case in T732.

This is a view from the HV side of the phase. There is an obvious difference between this unit and the phase 2 transformer. The conductors are not deformed or burned in this transformer.

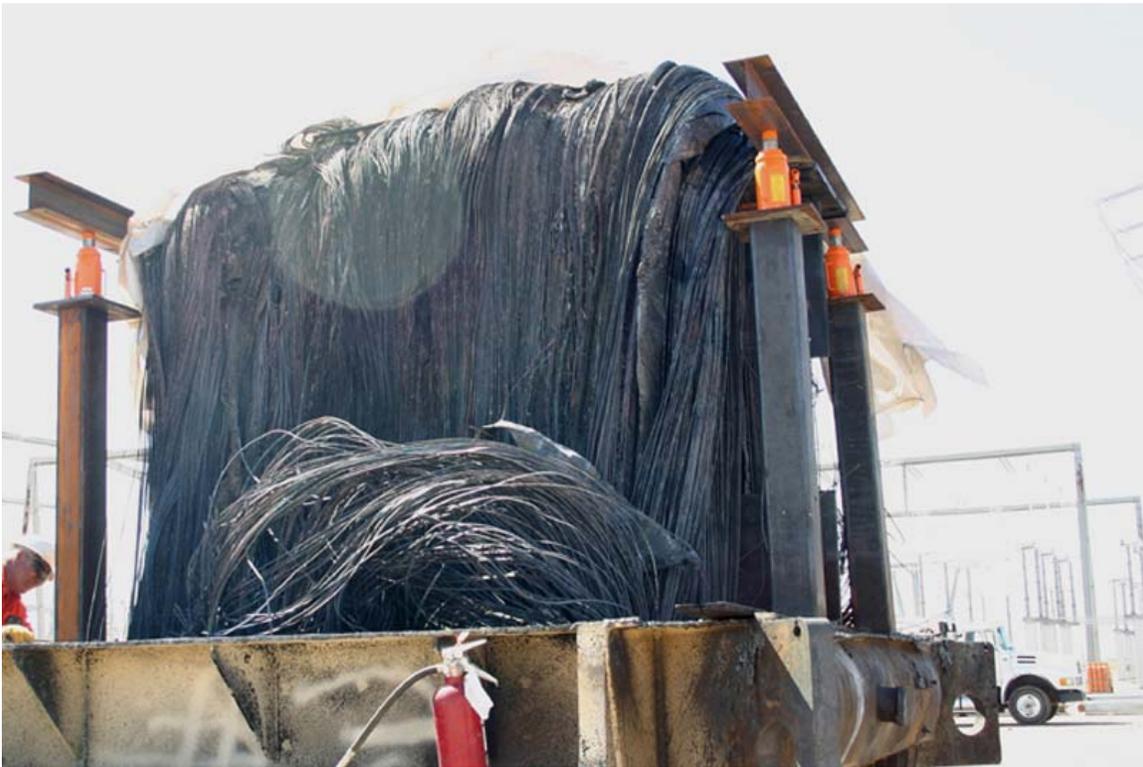
**Photo 30**

This is a view from the LV side. As with the HV side the conductors are not deformed. The conductors that appear deformed were cut and pulled into this position in the disassembly process.

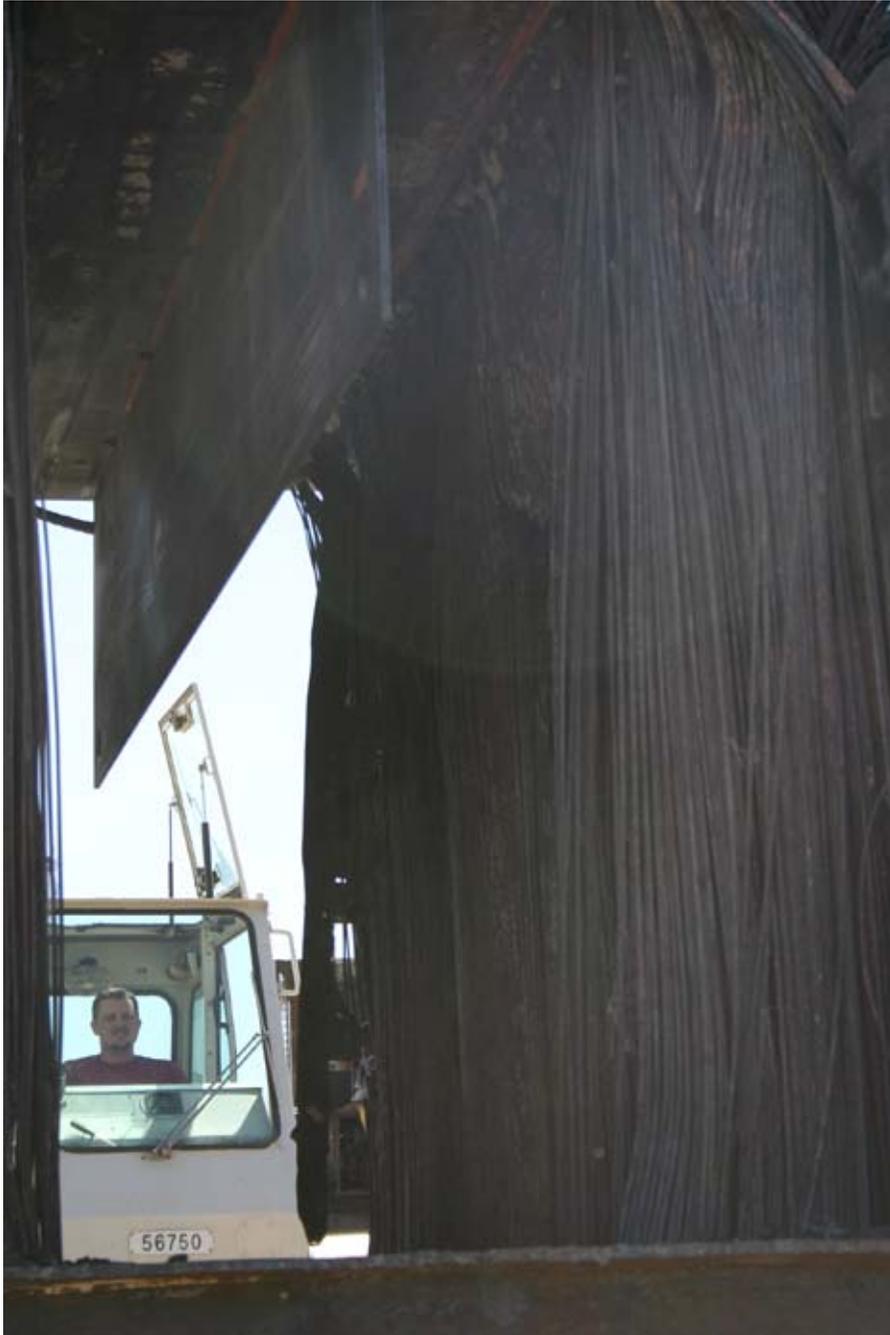
**Photo 31**

This is a view into the center hole through the phase assembly. The conductors are straight and are not deformed in this region.

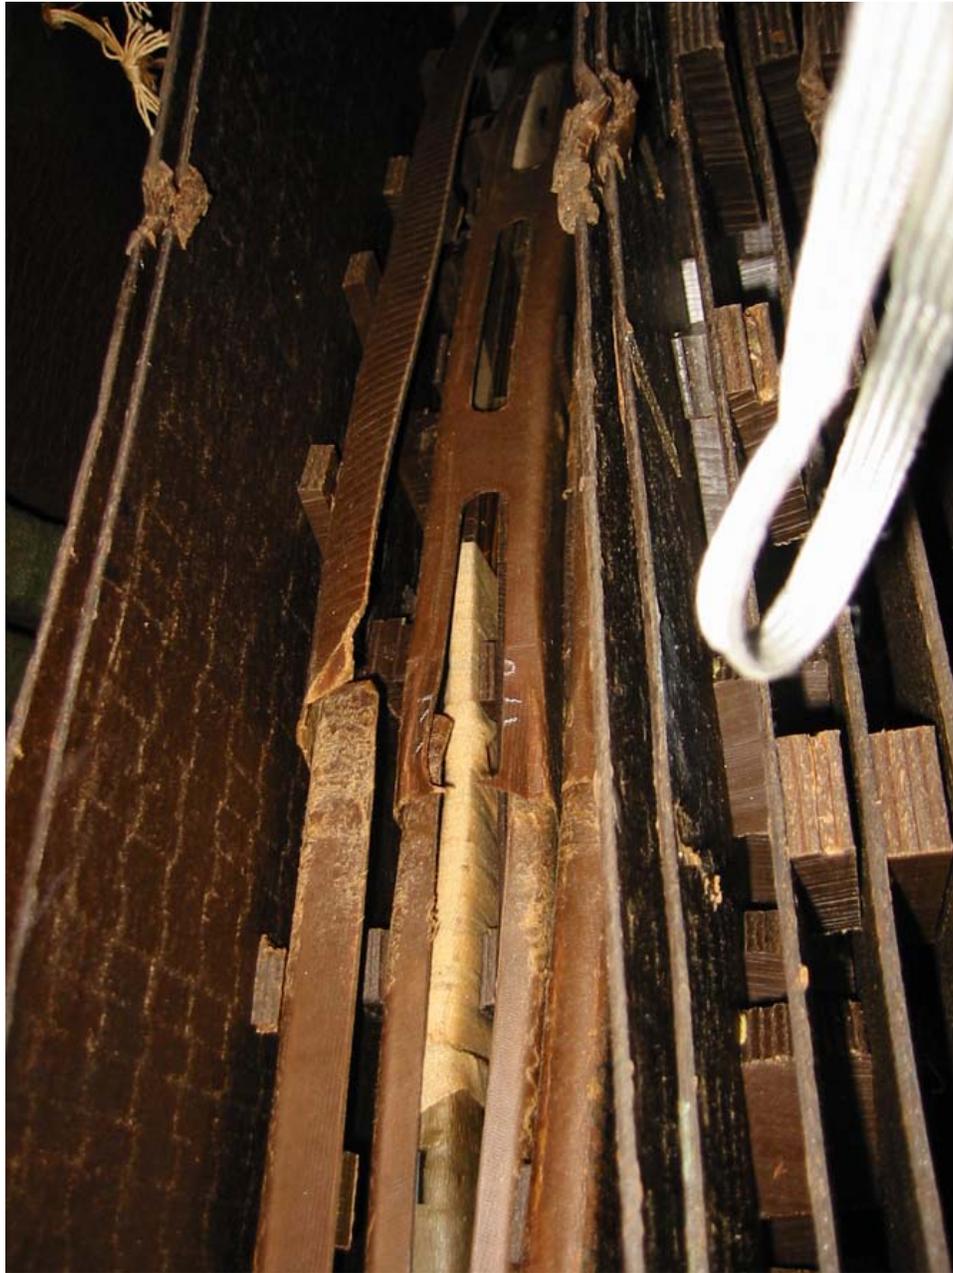
**Photo 33**

The internal inspection of T790 indicated some insulation items that were moved vertically out of position. It should be noted that T790 was not subjected to the long duration fault #5, thus the movement of insulation would have been exacerbated in T732 and T733 in comparison to that in T790. Unfortunately, the insulation was destroyed in T732 and T733 so this condition cannot be observed. However, there was indication of conductor deformation in the HV line group and the LV line group of T732. This movement would have been a reasonable result of the unidirectional force applied to the phase assembly for the prolonged period of time.

This is a view of the insulation at the top of the phase assembly for the HV line portion of the series winding. Note the vertical displacement of the formed angle in the left of center part of the photo.

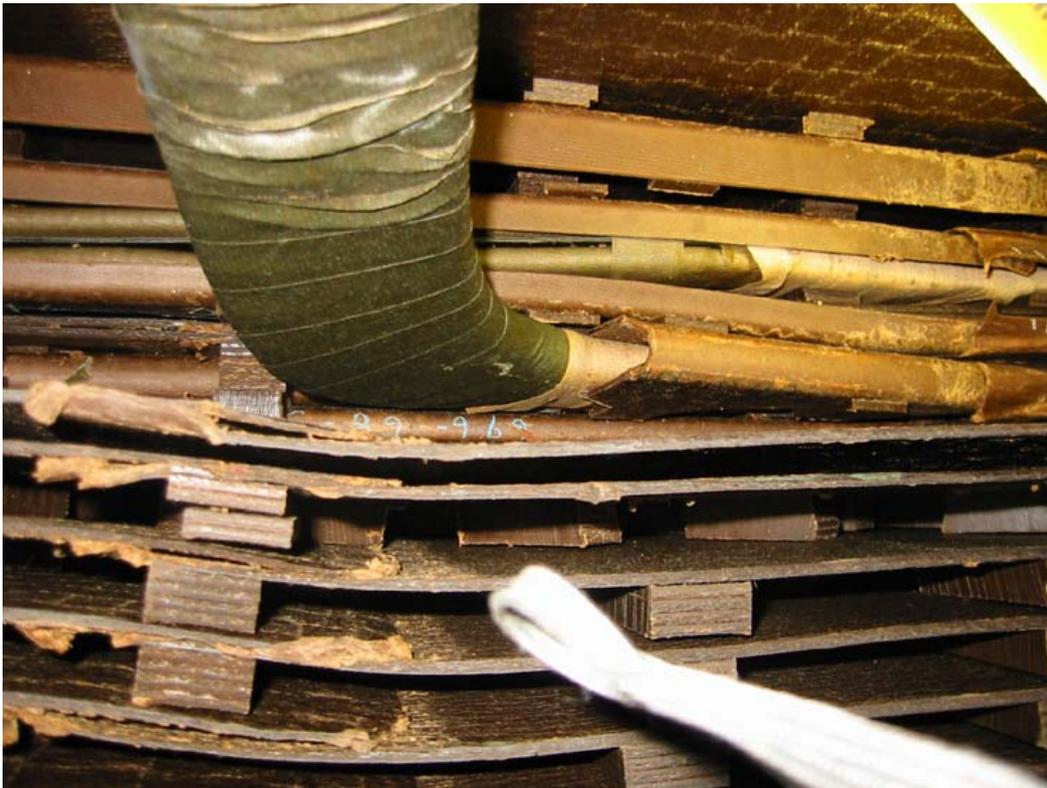
**Photo 34**

This is a view down onto the top of the phase assembly. The thin pieces of material are pressboard sheets referred to as washers. They go the full height and full width of the phase assembly. Note the bulge in the washers, which indicate some movement along the horizontal axis of the phase.

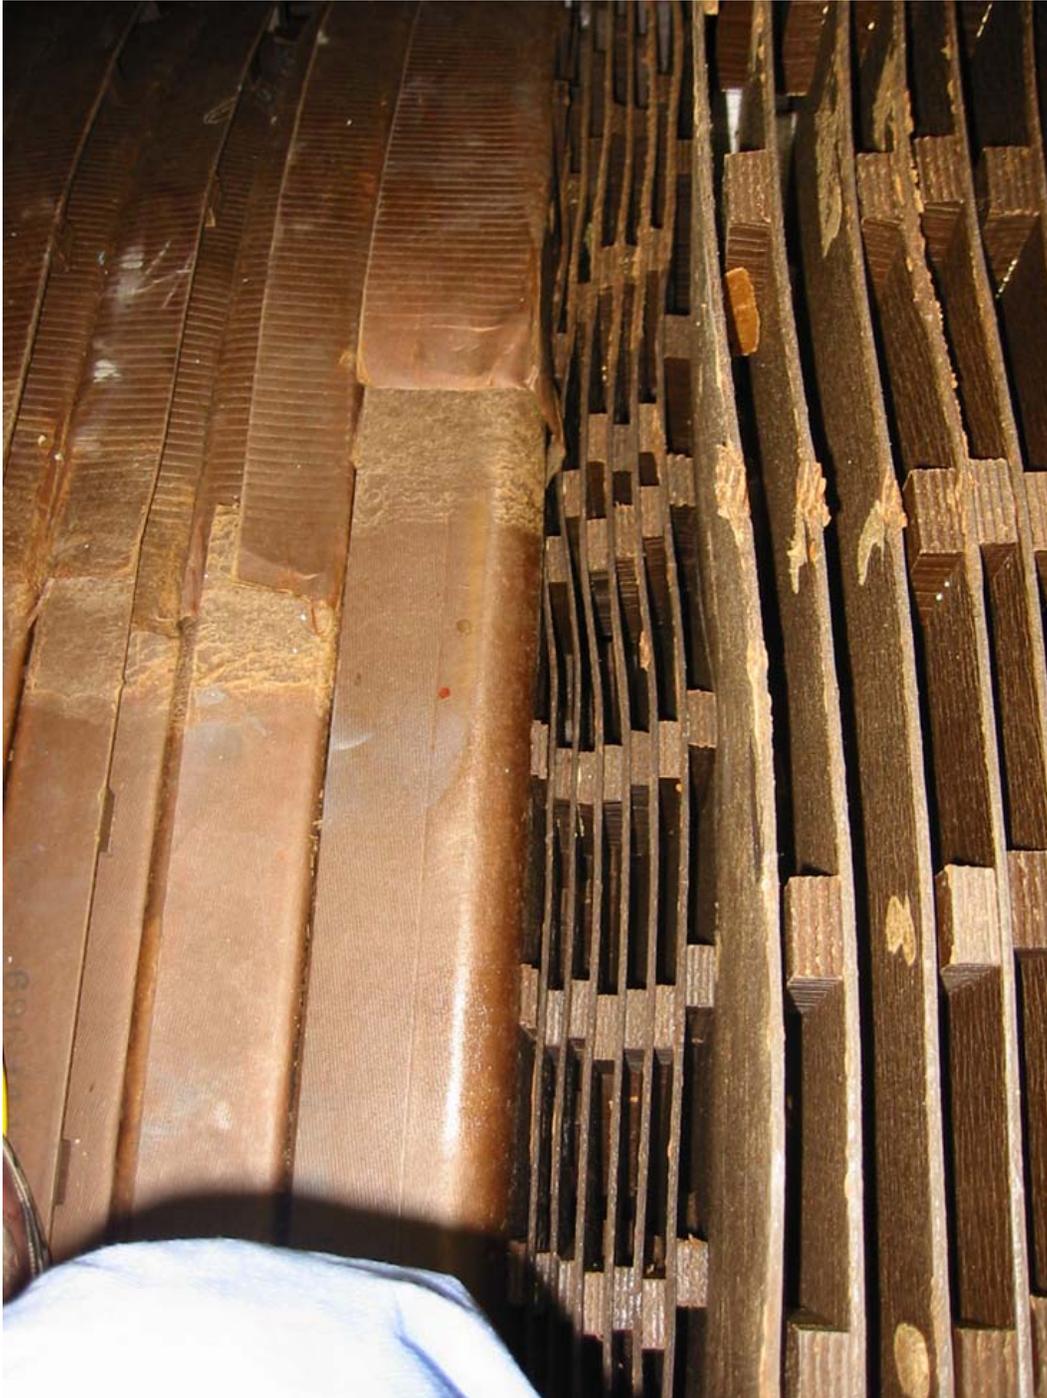
**Photo 35**

This is another area showing deflected washers. This is a different region from the previous photo.

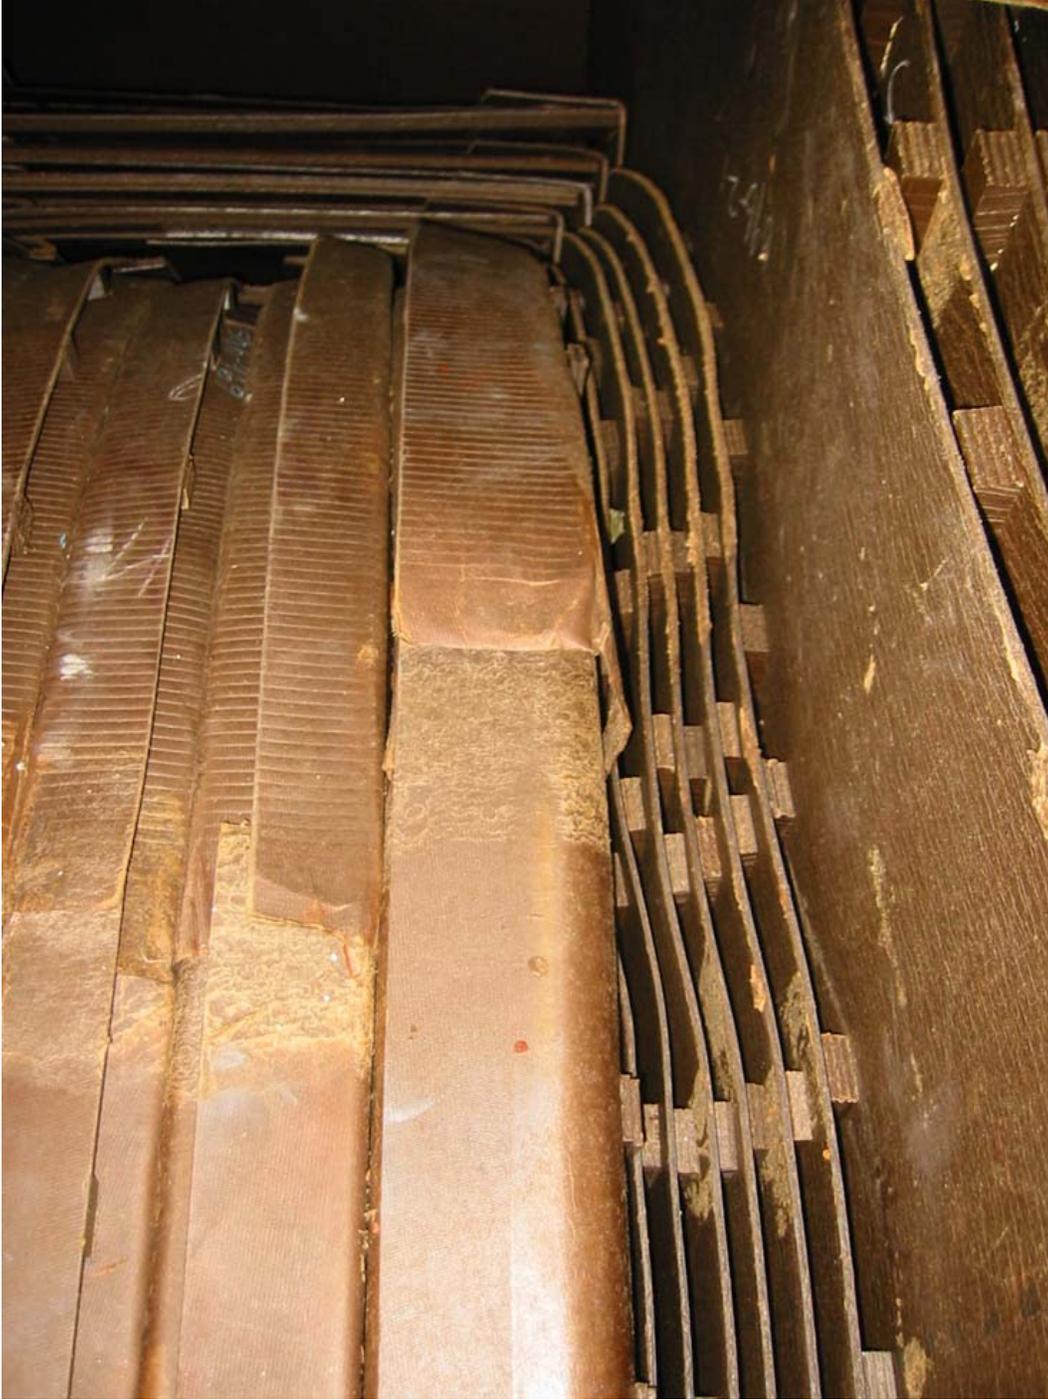
**Photo 36**

This is another area of deflected washers along the horizontal axis of the phase.

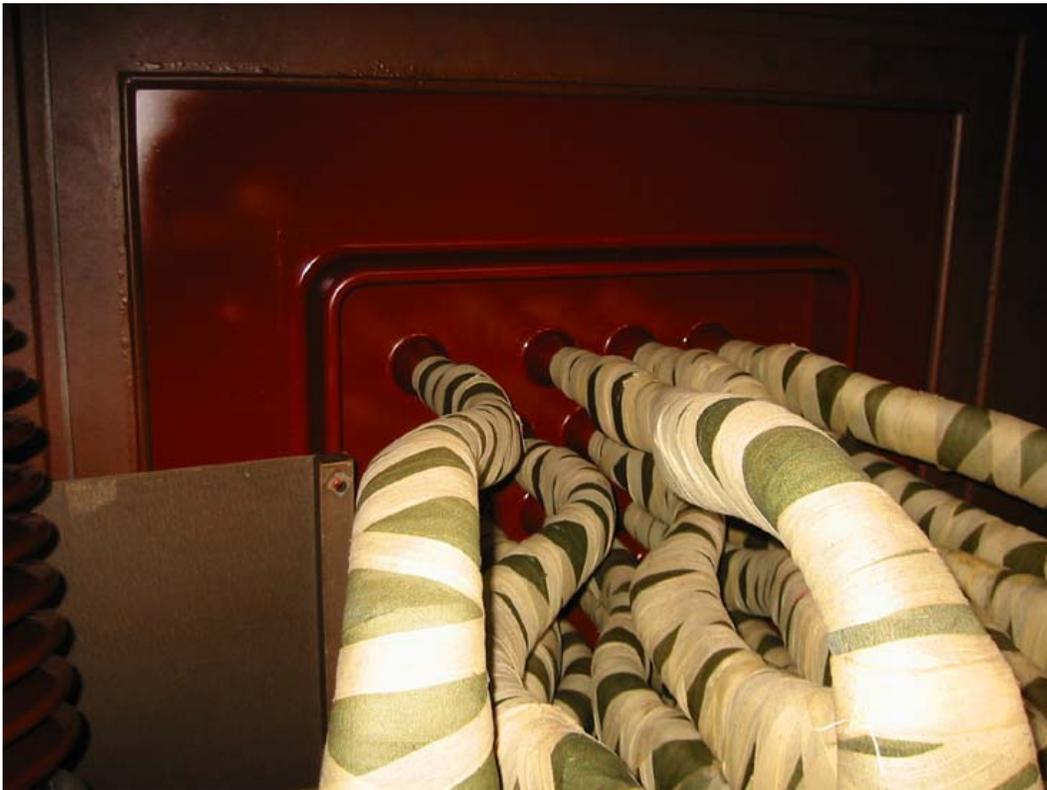
**Photo 37**

This photo shows the terminal board that was destroyed in transformers for phases 2 and 3 of the T1 bank. The leads are in their correct placement.
